# Access Compliance Report

## Public Rights-of-Way

### (Curb Ramps)

Intersection ID: 14152	Main Street: VILLAGE_CT	Cross Street: W_TREMONT_AV	Location: SE
ADA ID: D56B4051E4C0	Ramp Type: PerpDiag	Initial Pass/Fail: Fail	Overall Compliance: No
			Severity Score: 33.75

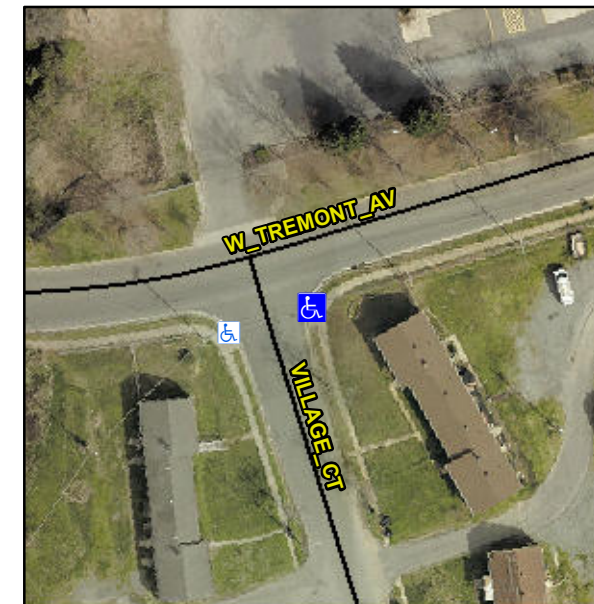
**Not Found, R304.5.1, R304.5.3**

Compliance	Description	Data	Compliance	Description	Data
N/A	Ramp Length (in)	50.0	Yes	Ramp Slope (%)	6.2
No	Ramp Width (in)	38.0	No	Ramp XSlope (%)	8.2
N/A	Flare Type LT	N/A	N/A	Flare Type RT	N/A
N/A	Flare Slope LT (%)	N/A	N/A	Flare Slope RT (%)	N/A
N/A	Flare Traversable LT?	N/A	N/A	Flare Traversable RT?	N/A
N/A	Landing Length (in)	N/A	N/A	DWS Provided?	N/A
N/A	Landing Width (in)	N/A	N/A	DWS Contrast?	N/A
N/A	Landing Slope (%)	N/A	N/A	DWS Length (in)	N/A
N/A	Landing X Slope (%)	N/A	N/A	DWS Full Width?	N/A
N/A	Landing Curb? (Y/N)	N/A	N/A	DWS Offset (in)	N/A
N/A	Shared Landing?	N/A			
N/A	Gutter Ponding?	N/A	N/A	Gutter Slope (%)	N/A
N/A	Gutter Lip Ht (in)	N/A	N/A	Gutter X Slope (%)	N/A
N/A	Painted X Walk1?	No	N/A	Painted X Walk2?	No
	X Walk 1 Direction	To N		X Walk 2 Direction	To W
N/A	X Walk 1 Width (in)	N/A	N/A	X Walk 2 Width (in)	N/A
	X Walk 1 Slope (%)	4.9		X Walk 2 Slope (%)	0.8
	X Walk 1 X Slope (%)	5.2		X Walk 2 X Slope (%)	4.2

N/A	Ramp inside XWalk1?	N/A	N/A	Ramp inside XWalk2?	N/A
	Road Slope (%)	5.8	N/A	Clear Space?	N/A
	Road X Slope (%)	2.3	N/A	Clear Space to XWalk (in)	N/A
N/A	Any Obstructions?	N/A	N/A	Storm Grate/Utility Hazard?	N/A
	Obstruction Type			Storm Grate/Utility Type	
		N/A			N/A
			Yes	Surface Condition? (G/P)	Good

**Remove & Replace Curb Ramp With Two New Directional Ramps or Equivalent.**

Total Cost: \$ 3200.00
