# Access Compliance Report

## Public Rights-of-Way

### (Curb Ramps)

| Intersection ID: 27687 | Main Street: BALLANTYNE_COUNTRY_CLUB_DR | Cross Street: LEE MANOR_LN | Location: SW |

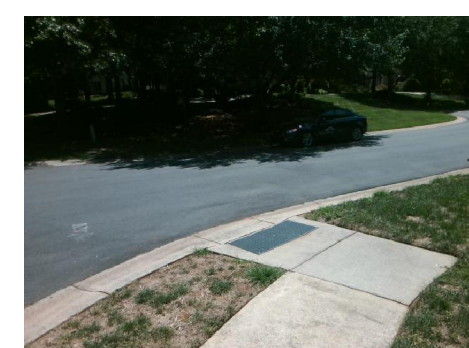
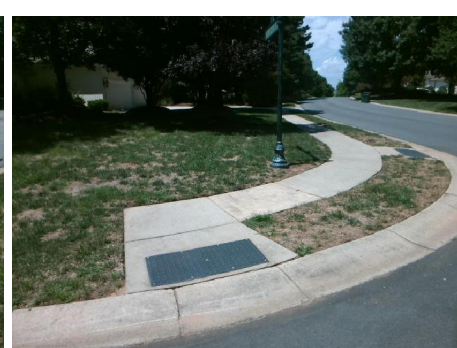
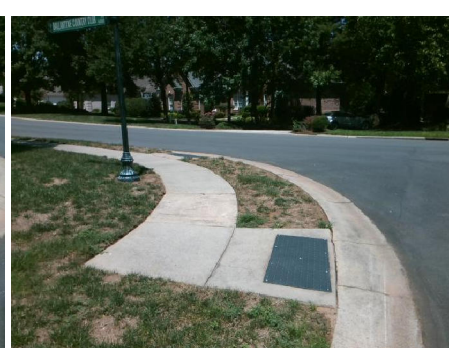
| ADA ID: D56B497E67B5 | Ramp Type: Perp | Initial Pass/Fail: Fail | Overall Compliance: No |

| Codes/Mitigation Info/Possible Solution | | | Field Measurements/Component Compliance | | | | | |
|---|---|---|---|---|---|---|---|---|
| | Remove & Replace Entire Ramp. | | N/A | Ramp Length (in) | 46.0 | No | Ramp Slope (%) | 9.6 |
| | | | No | Ramp Width (in) | 42.0 | Yes | Ramp XSlope (%) | 0.5 |
| PROW/ADA: | | R304.5.1, R304.2.2 | N/A | Shared Landing? | N/A | | | |
