Access Compliance Report

Public Rights-of-Way

(Curb Ramps)

Intersection ID: 11566	Main Street: GRANDIN_RD	Cross Street: LITAKER_AV	Location:	N
ADA ID: D56CFBA7A26F	Ramp Type: Perp	Initial Pass/Fail: Fail	Overall Compliance: No	Severity Score: 21.25

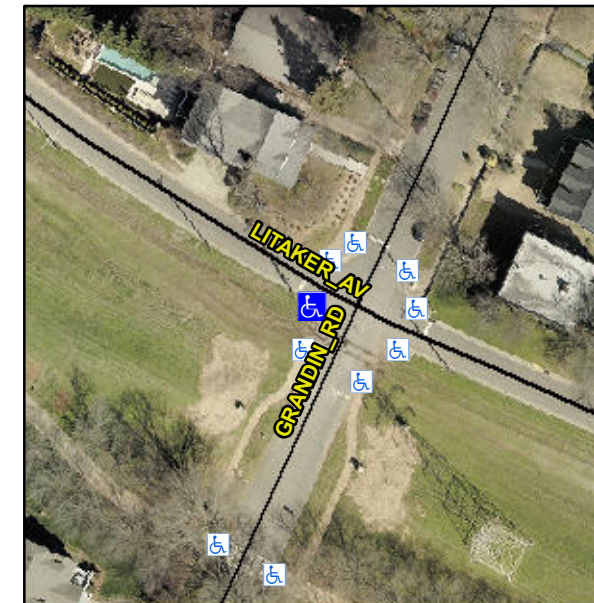
Not Found, R304.5.1, R304.5.3

Compliance	Description	Data	Compliance	Description	Data
N/A	Ramp Length (in)	54.5	Yes	Ramp Slope (%)	5.0
No	Ramp Width (in)	47.5	No	Ramp XSlope (%)	6.8
N/A	Flare Type LT	N/A	N/A	Flare Type RT	N/A
N/A	Flare Slope LT (%)	N/A	N/A	Flare Slope RT (%)	N/A
N/A	Flare Traversable LT?	N/A	N/A	Flare Traversable RT?	N/A
N/A	Landing Length (in)	N/A	N/A	DWS Provided?	N/A
N/A	Landing Width (in)	N/A	N/A	DWS Contrast?	N/A
N/A	Landing Slope (%)	N/A	N/A	DWS Length (in)	N/A
N/A	Landing X Slope (%)	N/A	N/A	DWS Full Width?	N/A
N/A	Landing Curb? (Y/N)	N/A	N/A	DWS Offset (in)	N/A
N/A	Shared Landing?	N/A			
N/A	Gutter Ponding?	N/A	N/A	Gutter Slope (%)	N/A
N/A	Gutter Lip Ht (in)	0.5	N/A	Gutter X Slope (%)	N/A
N/A	Painted X Walk1?	No	N/A	Painted X Walk2?	N/A
	X Walk 1 Direction	To NE		X Walk 2 Direction	N/A
N/A	X Walk 1 Width (in)	N/A	N/A	X Walk 2 Width (in)	N/A
	X Walk 1 Slope (%)	4.3		X Walk 2 Slope (%)	N/A
	X Walk 1 X Slope (%)	0.2		X Walk 2 X Slope (%)	N/A

N/A	Ramp inside XWalk1?	N/A	N/A	Ramp inside XWalk2?	N/A
	Road Slope (%)	N/A	N/A	Clear Space?	N/A
	Road X Slope (%)	N/A	N/A	Clear Space to XWalk (in)	N/A
N/A	Any Obstructions?	N/A	N/A	Storm Grate/Utility Hazard?	N/A
	Obstruction Type			Storm Grate/Utility Type	
		N/A			N/A
			Yes	Surface Condition? (G/P)	Good

Remove & Replace Entire Ramp.
