# Access Compliance Report

## Public Rights-of-Way

### (Curb Ramps)

| Intersection ID: 6714 | Main Street: NEVIN_RD | Cross Street: LAKE_RD | Location: E |

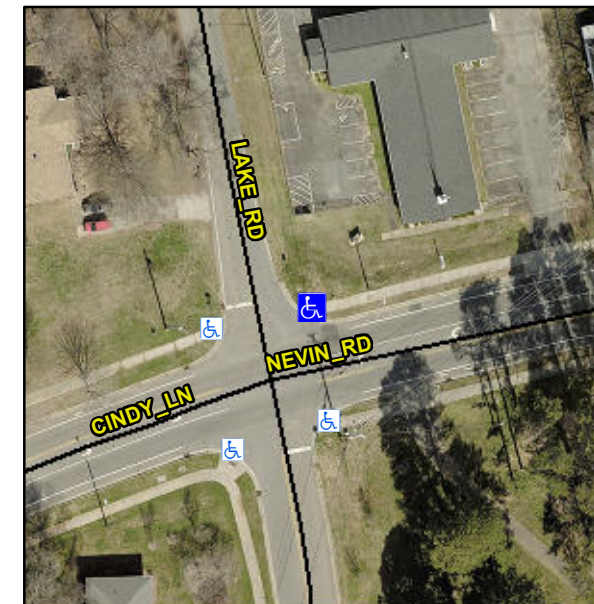
| Compliance | Description | Data | Compliance | Description | Data |
| Yes | Ramp Slope (%) | 5.8 | No | Grade Break XSlope (%) | 6.5 |
| No | Landing Slope (%) | 3.3 | Yes | DWS Length (in) | 24.0 |
| No | Landing X Slope (%) | 2.2 | No | DWS Full Width? | No |
| N/A | Shared Landing? | No | No | DWS Offset RT (in) | 11.0 |
| No | Gutter Lip Ht (in) | 0.5 | No | Gutter X Slope (%) | 5.5 |

Possible Solutions:

**Remove & Replace Entire Ramp.  
Remove & Replace Gutter.**

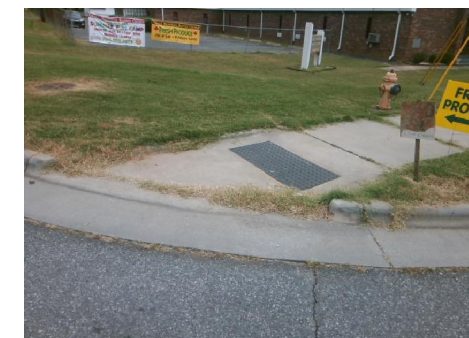
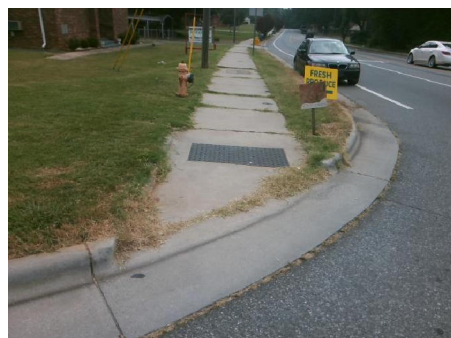
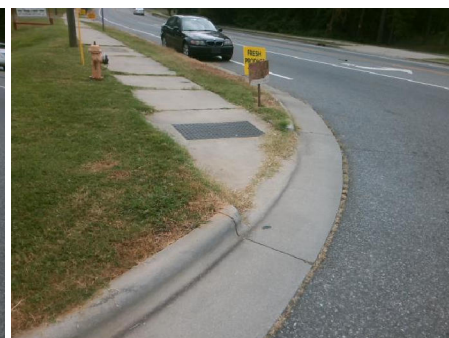
| ADA ID: D5739F73133E | Ramp Type: Directional1 | Initial Pass/Fail: Pass | Overall Compliance: No |
| | | Severity Score: 10 | |
