# Access Compliance Report

## Public Rights-of-Way

### (Curb Ramps)

Intersection ID: 6401	Main Street: MURPHY_HILL_PL	Cross Street: STINSON_GLEN_LN	Location: E
ADA ID: D5A4DD663292	Ramp Type: BlendTrans1	Initial Pass/Fail: Fail	Overall Compliance: No
		Severity Score: 25

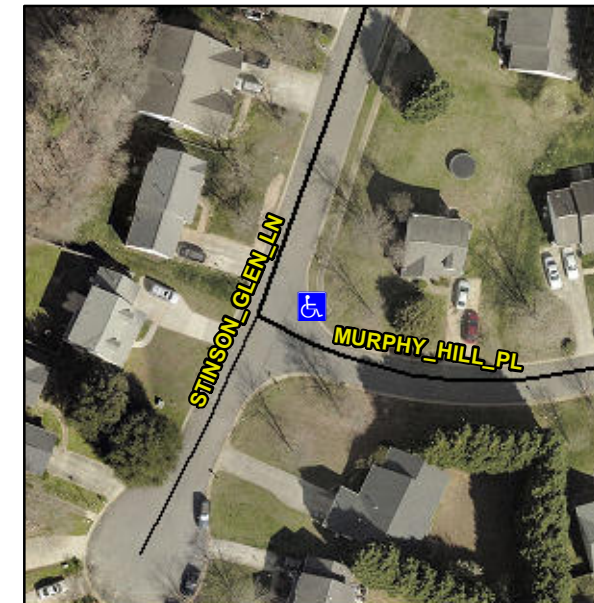
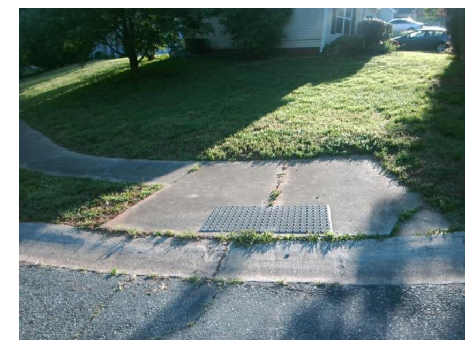
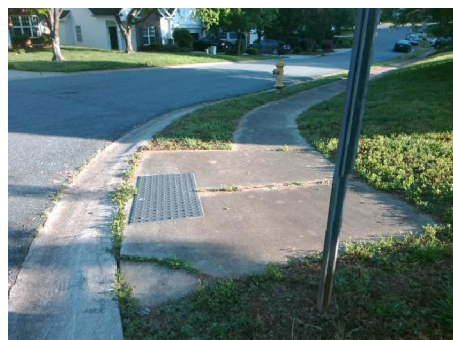
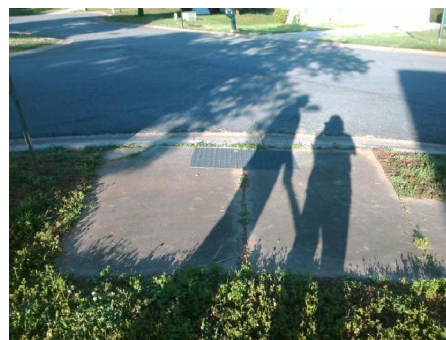
**NO RT SW**

**Not Found, R304.5.3**

Compliance	Description	Data	Compliance	Description	Data
N/A	Ramp Length (in)	48.0	Yes	BlendTrans Slope (%)	2.1
Yes	Ramp Width (in)	48.0	No	BlendTrans XSlope (%)	9.8
N/A	Flare Type LT	N/A	N/A	Flare Type RT	N/A
N/A	Flare Slope LT (%)	N/A	N/A	Flare Slope RT (%)	N/A
N/A	Flare Traversable LT?	N/A	N/A	Flare Traversable RT?	N/A
N/A	Landing Length (in)	N/A	N/A	DWS Provided?	N/A
N/A	Landing Width (in)	N/A	N/A	DWS Contrast?	N/A
N/A	Landing Slope (%)	N/A	N/A	DWS Length (in)	N/A
N/A	Landing X Slope (%)	N/A	N/A	DWS Full Width?	N/A
N/A	Landing Curb? (Y/N)	N/A	N/A	DWS Offset (in)	N/A
N/A	Shared Landing?	N/A			
N/A	Gutter Ponding?	N/A	N/A	Gutter Slope (%)	N/A
N/A	Gutter Lip Ht (in)	N/A	N/A	Gutter X Slope (%)	N/A
N/A	Painted X Walk1?	No	N/A	Painted X Walk2?	No
	X Walk 1 Direction	To W		X Walk 2 Direction	To S
	X Walk 1 Width (in)	N/A		X Walk 2 Width (in)	N/A
	X Walk 1 Slope (%)	0.7		X Walk 2 Slope (%)	N/A
	X Walk 1 X Slope (%)	6.7		X Walk 2 X Slope (%)	N/A

N/A	Ramp inside XWalk1?	N/A	N/A	Ramp inside XWalk2?	N/A
	Road Slope (%)	6.7		Clear Space?	N/A
	Road X Slope (%)	0.7	N/A	Clear Space to XWalk (in)	N/A
N/A	Any Obstructions?	N/A	N/A	Storm Grate/Utility Hazard?	N/A
	Obstruction Type			Storm Grate/Utility Type	
		N/A			N/A
			Yes	Surface Condition? (G/P)	Good
			No	Curb Slope (%)	5.3

**Remove & Replace Curb Ramp With Two New Directional Ramps or Equivalent.**
