# Access Compliance Report

## Public Rights-of-Way

### (Curb Ramps)

| Intersection ID: 44070 | Main Street: SEDGEMOOR_LN | Cross Street: SOUTHAMPTON_COMMONS_DR | Location: NE |

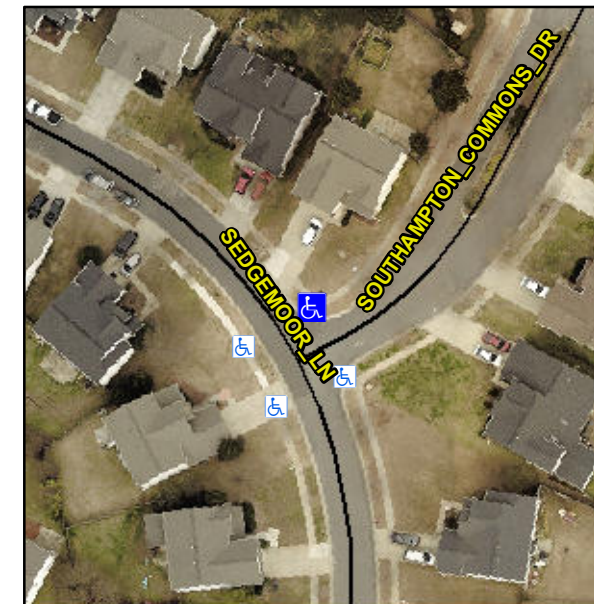
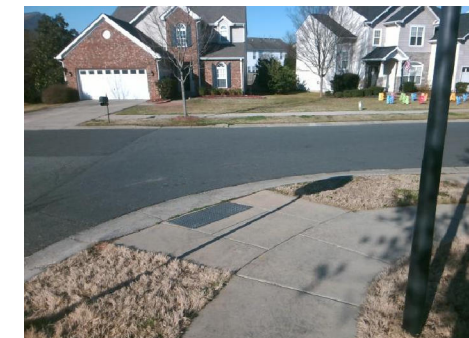
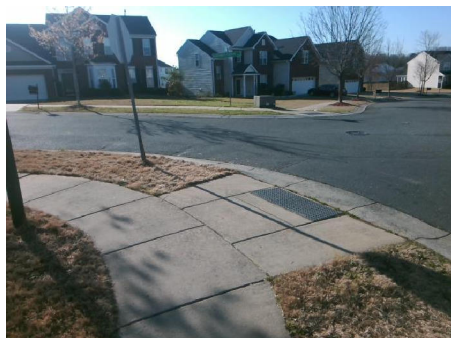
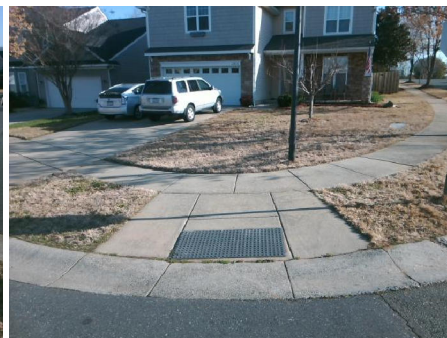
| ADA ID: D5ACAD2675CB | Ramp Type: PerpDiag | Initial Pass/Fail: Fail | Overall Compliance: No |

| Severity Score: 33.75 | | | |

| Compliance | Description | Data | Compliance | Description | Data |
|---|---|---|---|---|---|
| N/A | Ramp Length (in) | 74.0 | No | Ramp Slope (%) | 9.9 |
| No | Ramp Width (in) | 43.0 | No | Ramp XSlope (%) | 6.2 |

**Remove & Replace Curb Ramp With Two New Directional Ramps or Equivalent.**

**R304.5.1, R304.2.2, R304.5.3**

Total Cost: \$ 3200.00
