Access Compliance Report

Public Rights-of-Way (Curb Ramps)

| Intersection ID: 24686 | Main Street: GREENWIG_CT | Cross Street: HARLEQUIN_DR | Location: SW |
| ADA ID: D5AF813C5925 | Ramp Type: Directional1 | Initial Pass/Fail: Fail | Overall Compliance: No |

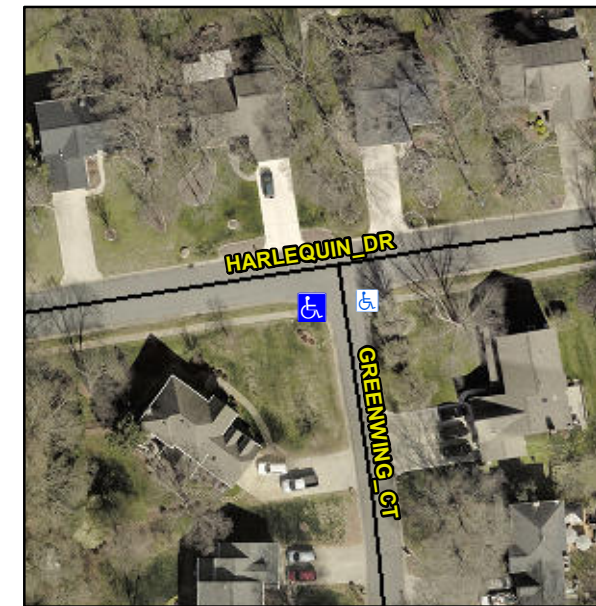
| Severity Score: 33.75 | | | |

R304.5.1, R304.5.3

| Compliance | Description | Data | Compliance | Description | Data |
|---|---|---|---|---|---|
| No | Ramp Width (in) | 41.0 | N/A | Grade Break Slope (%) | 0.0 |
| No | Ramp XSlope (%) | 7.4 | | | |

Remove & Replace Entire Ramp.
