# Access Compliance Report

## Public Rights-of-Way

### (Curb Ramps)

Intersection ID: 9951	Main Street: S_TURNER_AV	Cross Street: W_TRADE_ST	Location:	N
ADA ID: D5AFA24FB217	Ramp Type: Perp	Initial Pass/Fail: Fail	Overall Compliance: No	Severity Score: 26.25
Codes/Mitigation Info/Possible Solution		Field Measurements/Component Compliance

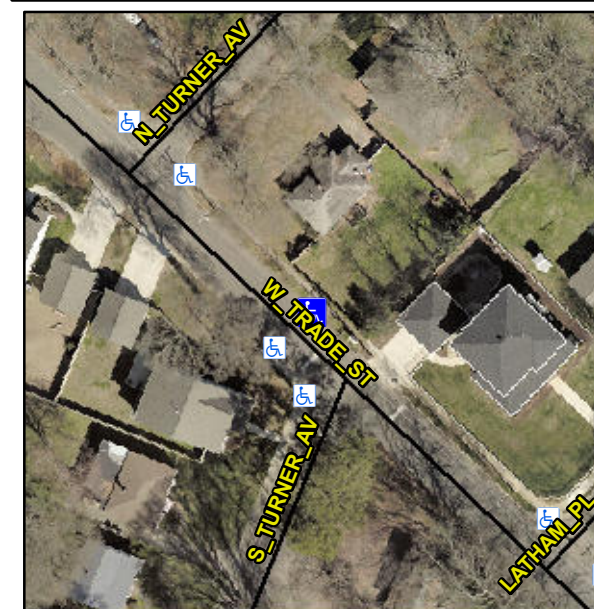
**Not Found, R304.2.2, R304.5.3**

Compliance	Description	Data	Compliance	Description	Data
N/A	Ramp Length (in)	50.0	No	Ramp Slope (%)	15.5
Yes	Ramp Width (in)	48.0	No	Ramp XSlope (%)	3.7
N/A	Flare Type LT	N/A	N/A	Flare Type RT	N/A
N/A	Flare Slope LT (%)	N/A	N/A	Flare Slope RT (%)	N/A
N/A	Flare Traversable LT?	N/A	N/A	Flare Traversable RT?	N/A
N/A	Landing Length (in)	N/A	N/A	DWS Provided?	N/A
N/A	Landing Width (in)	N/A	N/A	DWS Contrast?	N/A
N/A	Landing Slope (%)	N/A	N/A	DWS Length (in)	N/A
N/A	Landing X Slope (%)	N/A	N/A	DWS Full Width?	N/A
N/A	Landing Curb? (Y/N)	N/A	N/A	DWS Offset (in)	N/A
N/A	Shared Landing?	N/A			
N/A	Gutter Ponding?	N/A	N/A	Gutter Slope (%)	N/A
N/A	Gutter Lip Ht (in)	N/A	N/A	Gutter X Slope (%)	N/A
N/A	Painted X Walk1?	No	N/A	Painted X Walk2?	N/A
	X Walk 1 Direction	To SW		X Walk 2 Direction	N/A
N/A	X Walk 1 Width (in)	N/A	N/A	X Walk 2 Width (in)	N/A
	X Walk 1 Slope (%)	1.4		X Walk 2 Slope (%)	N/A
	X Walk 1 X Slope (%)	3.8		X Walk 2 X Slope (%)	N/A

N/A	Ramp inside XWalk1?	N/A	N/A	Ramp inside XWalk2?	N/A
	Road Slope (%)	N/A	N/A	Clear Space?	N/A
	Road X Slope (%)	N/A	N/A	Clear Space to XWalk (in)	N/A
N/A	Any Obstructions?	N/A	N/A	Storm Grate/Utility Hazard?	N/A
	Obstruction Type			Storm Grate/Utility Type	
		N/A			N/A
			Yes	Surface Condition? (G/P)	Good

**Remove & Replace Entire Ramp.**

Total Cost: \$ 1850.00
