Access Compliance Report

Public Rights-of-Way

(Curb Ramps)

Intersection ID: 44602	Main Street: JOHNSTON_OEHLER_RD	Cross Street: PROSPERITY_PARK_DR	Location: SW
ADA ID: D5B171E8DF5C	Ramp Type: Perp	Initial Pass/Fail: Fail	Overall Compliance: No
Severity Score: 37.5			
Codes/Mitigation Info/Possible Solution		Field Measurements/Component Compliance

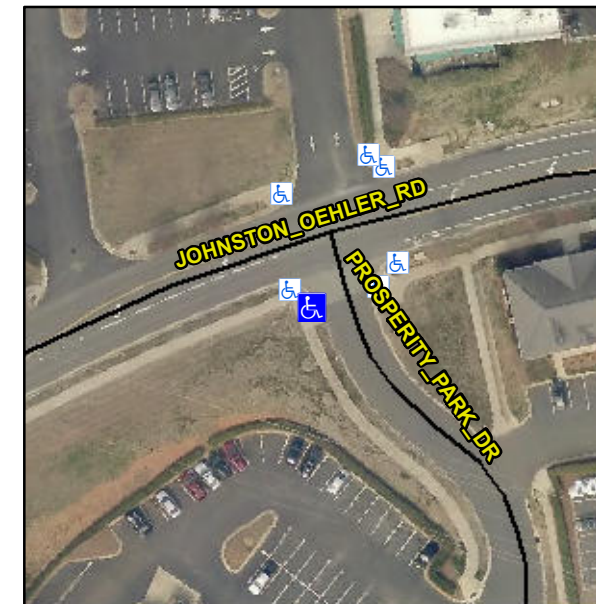
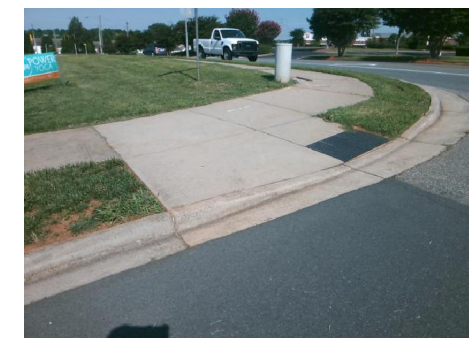
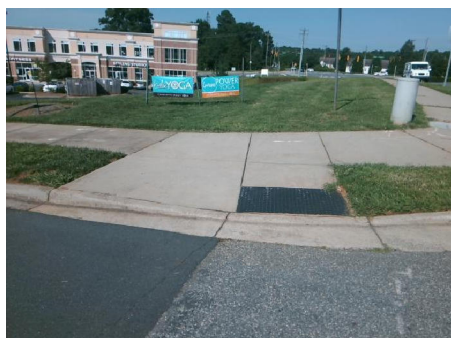
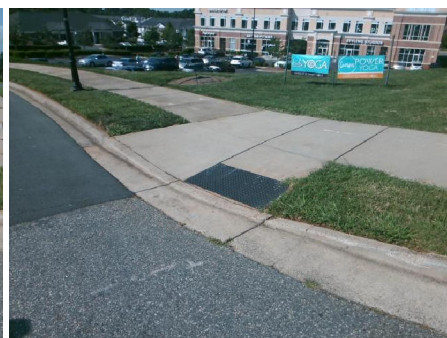
Compliance	Description	Data	Compliance	Description	Data
N/A	Ramp Length (in)	57.5	No	Ramp Slope (%)	9.6
Yes	Ramp Width (in)	48.0	No	Ramp XSlope (%)	8.9
N/A	Flare Type LT	N/A	N/A	Flare Type RT	N/A
N/A	Flare Slope LT (%)	N/A	N/A	Flare Slope RT (%)	N/A
N/A	Flare Traversable LT?	N/A	N/A	Flare Traversable RT?	N/A
N/A	Landing Length (in)	N/A	N/A	DWS Provided?	N/A
N/A	Landing Width (in)	N/A	N/A	DWS Contrast?	N/A
N/A	Landing Slope (%)	N/A	N/A	DWS Length (in)	N/A
N/A	Landing X Slope (%)	N/A	N/A	DWS Full Width?	N/A
N/A	Landing Curb? (Y/N)	N/A	N/A	DWS Offset (in)	N/A
N/A	Shared Landing?	N/A			
N/A	Gutter Ponding?	N/A	N/A	Gutter Slope (%)	N/A
N/A	Gutter Lip Ht (in)	N/A	N/A	Gutter X Slope (%)	N/A
N/A	Painted X Walk1?	No	N/A	Painted X Walk2?	N/A
	X Walk 1 Direction	To E		X Walk 2 Direction	N/A
N/A	X Walk 1 Width (in)	N/A	N/A	X Walk 2 Width (in)	N/A
	X Walk 1 Slope (%)	0.1		X Walk 2 Slope (%)	N/A
	X Walk 1 X Slope (%)	7.4		X Walk 2 X Slope (%)	N/A

N/A	Ramp inside XWalk1?	N/A	N/A	Ramp inside XWalk2?	N/A
	Road Slope (%)	N/A	N/A	Clear Space?	N/A
	Road X Slope (%)	N/A	N/A	Clear Space to XWalk (in)	N/A
N/A	Any Obstructions?	N/A	N/A	Storm Grate/Utility Hazard?	N/A
	Obstruction Type			Storm Grate/Utility Type	
		N/A			N/A
		Yes		Surface Condition? (G/P)	Good

Possible Solutions:

Remove & Replace Entire Ramp.

R304.2.2, R304.5.3
