Access Compliance Report

Public Rights-of-Way

(Curb Ramps)

Intersection ID: 46310		Main Street: BRIDLE_BROOK_WY		Cross Street: BECKET_RIDGE_RD		Location: SE			
ADA ID: D5BC6687CF0F		Ramp Type: PerpDiag		Initial Pass/Fail: Fail		Overall Compliance: No		Severity Score: 10	
Codes/Mitigation Info/Possible Solution					Field Measurements/Component Compliance

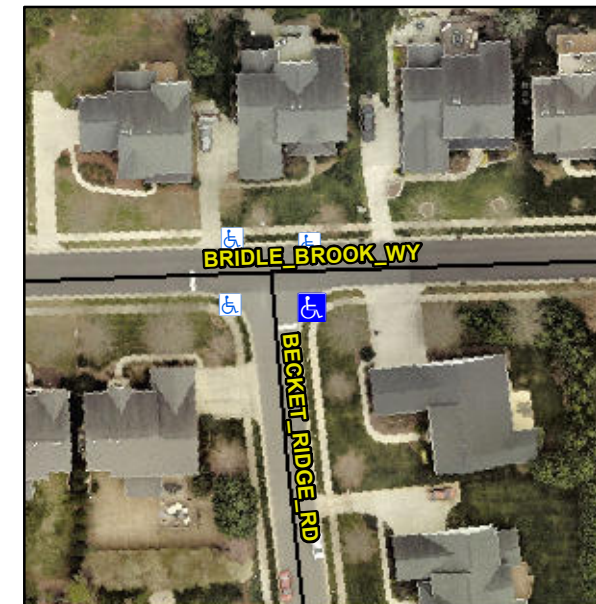
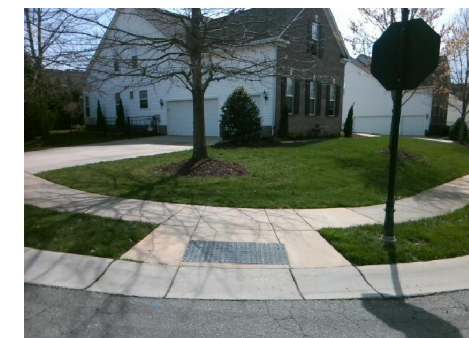
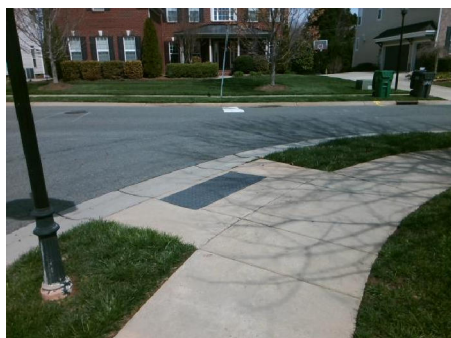
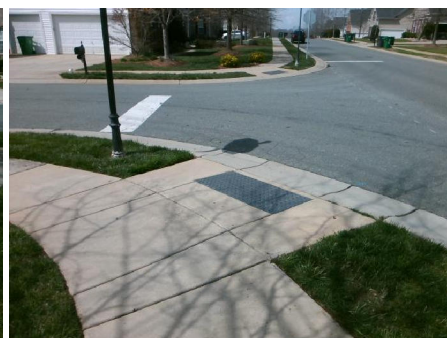
Not Found, R304.5.1, R304.5.3

Compliance	Description	Data	Compliance	Description	Data
N/A	Ramp Length (in)	48.0	Yes	Ramp Slope (%)	6.0
No	Ramp Width (in)	43.5	No	Ramp XSlope (%)	3.5
N/A	Flare Type LT	N/A	N/A	Flare Type RT	N/A
N/A	Flare Slope LT (%)	N/A	N/A	Flare Slope RT (%)	N/A
N/A	Flare Traversable LT?	N/A	N/A	Flare Traversable RT?	N/A
N/A	Landing Length (in)	N/A	N/A	DWS Provided?	N/A
N/A	Landing Width (in)	N/A	N/A	DWS Contrast?	N/A
N/A	Landing Slope (%)	N/A	N/A	DWS Length (in)	N/A
N/A	Landing X Slope (%)	N/A	N/A	DWS Full Width?	N/A
N/A	Landing Curb? (Y/N)	N/A	N/A	DWS Offset (in)	N/A
N/A	Shared Landing?	N/A			
N/A	Gutter Ponding?	N/A	N/A	Gutter Slope (%)	N/A
N/A	Gutter Lip Ht (in)	N/A	N/A	Gutter X Slope (%)	N/A
N/A	Painted X Walk1?	No	N/A	Painted X Walk2?	No
	X Walk 1 Direction	To N		X Walk 2 Direction	To W
N/A	X Walk 1 Width (in)	N/A	N/A	X Walk 2 Width (in)	N/A
	X Walk 1 Slope (%)	1.5		X Walk 2 Slope (%)	0.3
	X Walk 1 X Slope (%)	1.0		X Walk 2 X Slope (%)	3.3

N/A	Ramp inside XWalk1?	N/A	N/A	Ramp inside XWalk2?	N/A
	Road Slope (%)	1.8	N/A	Clear Space?	N/A
	Road X Slope (%)	2.8	N/A	Clear Space to XWalk (in)	N/A
N/A	Any Obstructions?	N/A	N/A	Storm Grate/Utility Hazard?	N/A
	Obstruction Type			Storm Grate/Utility Type	
		N/A			N/A
		Yes		Surface Condition? (G/P)	Good

Remove & Replace Curb Ramp With Two New Directional Ramps or Equivalent.

Total Cost: \$ 3200.00
