Access Compliance Report

Public Rights-of-Way

(Curb Ramps)

Intersection ID: 43363	Main Street: PROSPERITY_VIEW_DR	Cross Street: RIDGEVIEW_COMMONS_DR	Location: E
ADA ID: D5C129B30424	Ramp Type: PerpDiag	Initial Pass/Fail: Fail	Overall Compliance: No
		Severity Score: 8.75

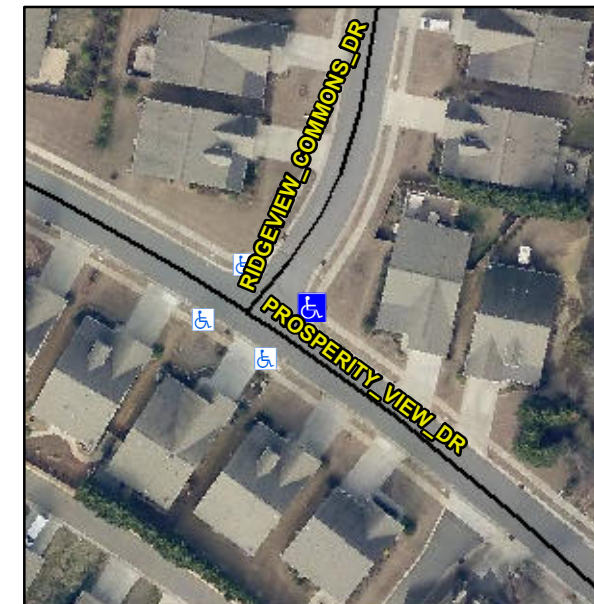
Compliance	Description	Data	Compliance	Description	Data
N/A	Ramp Length (in)	46.0	Yes	Ramp Slope (%)	7.2
No	Ramp Width (in)	38.0	Yes	Ramp XSlope (%)	1.9
N/A	Flare Type LT	N/A	N/A	Flare Type RT	N/A
N/A	Flare Slope LT (%)	N/A	N/A	Flare Slope RT (%)	N/A
N/A	Flare Traversable LT?	N/A	N/A	Flare Traversable RT?	N/A
N/A	Landing Length (in)	N/A	N/A	DWS Provided?	N/A
N/A	Landing Width (in)	N/A	N/A	DWS Contrast?	N/A
N/A	Landing Slope (%)	N/A	N/A	DWS Length (in)	N/A
N/A	Landing X Slope (%)	N/A	N/A	DWS Full Width?	N/A
N/A	Landing Curb? (Y/N)	N/A	N/A	DWS Offset (in)	N/A
N/A	Shared Landing?	N/A			
N/A	Gutter Ponding?	N/A	N/A	Gutter Slope (%)	N/A
N/A	Gutter Lip Ht (in)	N/A	N/A	Gutter X Slope (%)	N/A
N/A	Painted X Walk1?	No	N/A	Painted X Walk2?	No
	X Walk 1 Direction	To NW		X Walk 2 Direction	To SW
N/A	X Walk 1 Width (in)	N/A	N/A	X Walk 2 Width (in)	N/A
	X Walk 1 Slope (%)	0.9		X Walk 2 Slope (%)	2.7
	X Walk 1 X Slope (%)	0.7		X Walk 2 X Slope (%)	1.3

N/A	Ramp inside XWalk1?	N/A	N/A	Ramp inside XWalk2?	N/A
	Road Slope (%)	1.9	N/A	Clear Space?	N/A
	Road X Slope (%)	0.7	N/A	Clear Space to XWalk (in)	N/A
N/A	Any Obstructions?	N/A	N/A	Storm Grate/Utility Hazard?	N/A
	Obstruction Type			Storm Grate/Utility Type	
		N/A			N/A
			Yes	Surface Condition? (G/P)	Good

Possible Solutions:

Remove & Replace Curb Ramp With Two New Directional Ramps or Equivalent.
