Access Compliance Report

Public Rights-of-Way

(Curb Ramps)

Intersection ID: 9356	Main Street: E_36TH_ST	Cross Street: N_TRYON_ST	Location: NE
ADA ID: D5C33F607CF4	Ramp Type: Perp	Initial Pass/Fail: Fail	Overall Compliance: No
Severity Score: 25			
Codes/Mitigation Info/Possible Solution		Field Measurements/Component Compliance

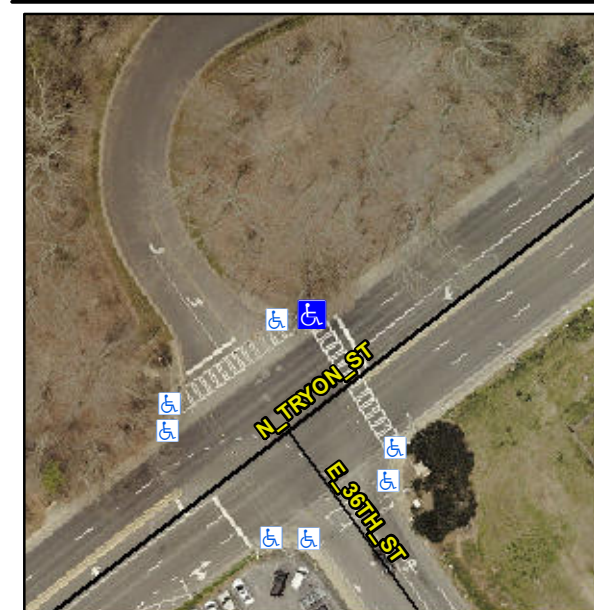
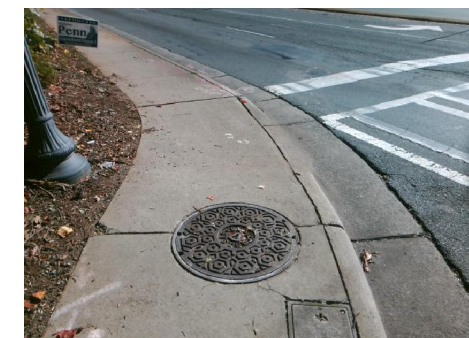
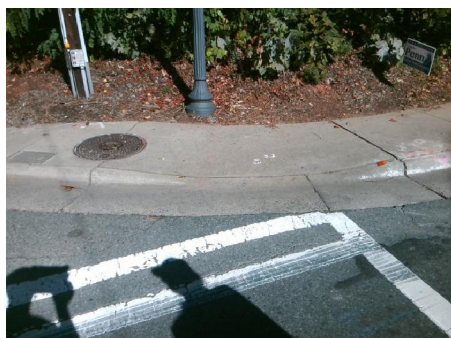
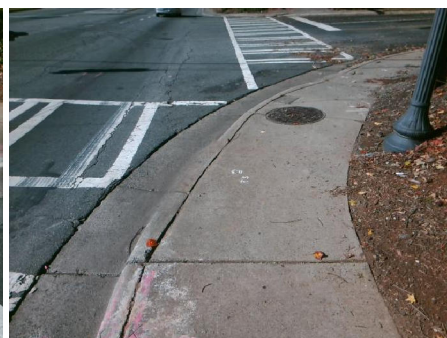
Not Found, R304.2.2, R304.5.3

Compliance	Description	Data	Compliance	Description	Data
N/A	Ramp Length (in)	60.0	No	Ramp Slope (%)	11.3
Yes	Ramp Width (in)	51.0	No	Ramp XSlope (%)	5.3
N/A	Flare Type LT	N/A	N/A	Flare Type RT	N/A
N/A	Flare Slope LT (%)	N/A	N/A	Flare Slope RT (%)	N/A
N/A	Flare Traversable LT?	N/A	N/A	Flare Traversable RT?	N/A
N/A	Landing Length (in)	N/A	N/A	DWS Provided?	N/A
N/A	Landing Width (in)	N/A	N/A	DWS Contrast?	N/A
N/A	Landing Slope (%)	N/A	N/A	DWS Length (in)	N/A
N/A	Landing X Slope (%)	N/A	N/A	DWS Full Width?	N/A
N/A	Landing Curb? (Y/N)	N/A	N/A	DWS Offset (in)	N/A
N/A	Shared Landing?	N/A			
N/A	Gutter Ponding?	N/A	N/A	Gutter Slope (%)	N/A
N/A	Gutter Lip Ht (in)	1.5	N/A	Gutter X Slope (%)	N/A
N/A	Painted X Walk1?	Yes	N/A	Painted X Walk2?	N/A
	X Walk 1 Direction	To SE		X Walk 2 Direction	N/A
N/A	X Walk 1 Width (in)	109.0	N/A	X Walk 2 Width (in)	N/A
	X Walk 1 Slope (%)	2.6		X Walk 2 Slope (%)	N/A
	X Walk 1 X Slope (%)	4.7		X Walk 2 X Slope (%)	N/A

N/A	Ramp inside XWalk1?	Yes	N/A	Ramp inside XWalk2?	N/A
	Road Slope (%)	N/A	N/A	Clear Space?	N/A
	Road X Slope (%)	N/A	N/A	Clear Space to XWalk (in)	N/A
N/A	Any Obstructions?	N/A	N/A	Storm Grate/Utility Hazard?	N/A
	Obstruction Type			Storm Grate/Utility Type	
		N/A			N/A
		Yes		Surface Condition? (G/P)	Good

Remove & Replace Entire Ramp.
