# Access Compliance Report

## Public Rights-of-Way

### (Curb Ramps)

| Intersection ID: 19960 | Main Street: ARCHDALE_DR | Cross Street: NETHERWOOD_DR | Location: NE |

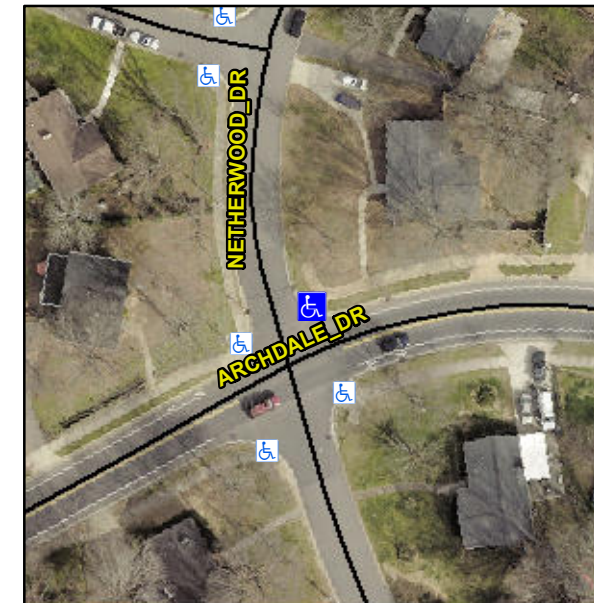
**Not Found, R304.5.1, R304.2.2**

| Compliance | Description | Data | Compliance | Description | Data |
|---|---|---|---|---|---|
| N/A | Ramp Length (in) | 71.0 | No | Ramp Slope (%) | 9.6 |
| No | Ramp Width (in) | 47.0 | Yes | Ramp XSlope (%) | 0.8 |

**Remove & Replace Curb Ramp With Two New Directional Ramps or Equivalent.**
