# Access Compliance Report

## Public Rights-of-Way

### (Curb Ramps)

| Intersection ID: N/A | Main Street: MATHER_GREEN_AV | Cross Street: N/A | Location: SW |

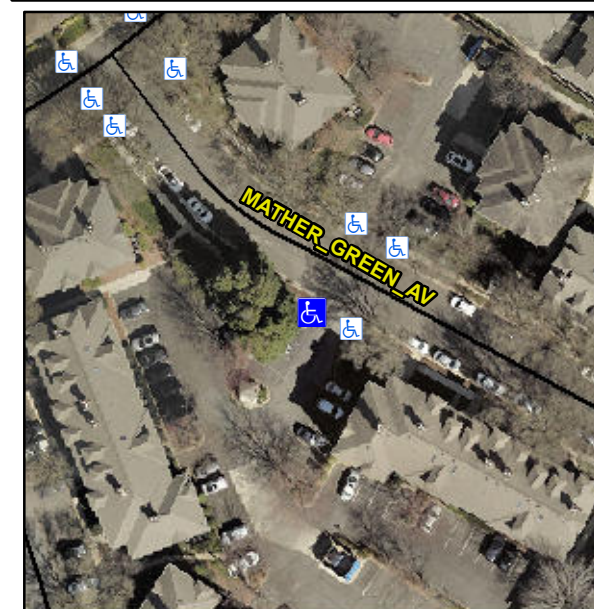
| ADA ID: D5D615A813FF | Ramp Type: PerpDiag | Initial Pass/Fail: Fail | Overall Compliance: No |
| Severity Score: 13.75 | | | |

**Not Found, R304.2.2, R304.5.3**

| Compliance | Description | Data | Compliance | Description | Data |
|---|---|---|---|---|---|
| N/A | Ramp Length (in) | 66.0 | No | Ramp Slope (%) | 11.4 |
| Yes | Ramp Width (in) | 48.0 | No | Ramp XSlope (%) | 3.4 |

**Remove & Replace Curb Ramp With Two New Directional Ramps or Equivalent.**

Total Cost: \$ 3200.00
