Access Compliance Report Public Rights-of-Way (Curb Ramps)

Intersection ID: 19296 Main Street: MEADOWOOD LN **Cross Street: PROVIDENCE RD** Location: NW ADA ID: D5DAEB84C247 Ramp Type: ParaDiag Initial Pass/Fail: Fail **Overall Compliance: No Severity Score:** 35

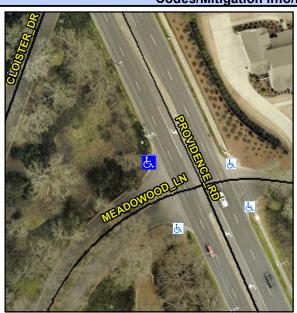
LT RP < 5%

Field Measurements/Component Compliance					
Compliance Description D		Data	Compliance Description		Data
N/A	Ramp Length LT (in)	51.0	N/A	Ramp Length RT (in)	65.0
No	Ramp Width LT (in)	38.0	No	Ramp Width RT (in)	37.0
Yes	Ramp Slope LT (%)	2.0	No	Ramp Slope RT (%)	14.4
No	Ramp XSlope LT (%)	3.5	No	Ramp XSlope RT (%)	3.1
N/A	Landing Length (in)	N/A	N/A	DWS Provided?	N/A
N/A	Landing Width (in)	N/A	N/A	DWS Contrast?	N/A
N/A	Landing Slope (%)	N/A	N/A	DWS Length (in)	N/A
N/A	Landing X Slope (%)	N/A	N/A	DWS Full Width?	N/A
N/A	Landing Curb? (Y/N)	N/A	N/A	DWS Offset (in)	N/A
N/A	Shared Landing?	N/A			
N/A	Gutter Ponding?	N/A	N/A	Gutter Slope (%)	N/A
N/A	Gutter Lip Ht (in)	N/A	N/A	Gutter X Slope (%)	N/A
N/A	Painted X Walk1?	No	N/A	Painted X Walk2?	No
	X Walk 1 Direction	To SE		X Walk 2 Direction	To NE
N/A	X Walk 1 Width (in)	N/A	N/A	X Walk 2 Width (in)	N/A
	X Walk 1 Slope (%)	0.1		X Walk 2 Slope (%)	7.9
	X Walk 1 X Slope (%)	4.7		X Walk 2 X Slope (%)	2.6

N/A	Ramp inside XWalk1?	N/A	N/A	Ramp inside XWalk2?	N/A
	Road Slope (%)	5.4	N/A	Clear Space?	N/A
	Road X Slope (%)	5.0	N/A	Clear Space to XWalk (in)	N/A
N/A	Any Obstructions?	N/A	N/A	Storm Grate/Utility Hazard?	N/A
	Obstruction Type			Storm Grate/Utility Type	
		N/A			N/A
			Yes	Surface Condition? (G/P)	Good
			N/A	Curb Slope (%)	2.4

Remove & Replace Curb Ramp With Two New Directional Ramps or Equivalent.

R304.5.1, R304.5.3, R304.3.2

3200.00
