# Access Compliance Report

## Public Rights-of-Way

### (Curb Ramps)

| Intersection ID: 51610 | Main Street: LUMSDEN_RD | Cross Street: REEFTON_RD | Location: W |

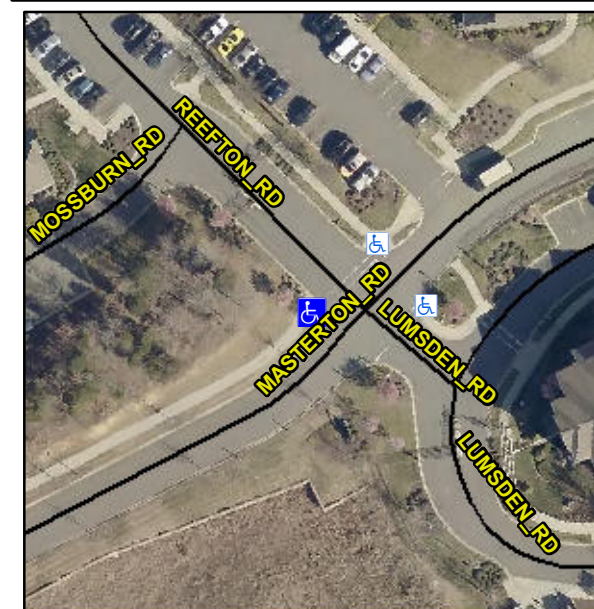
| ADA ID: D5E986F388F6 | Ramp Type: PerpDiag | Initial Pass/Fail: Fail | Overall Compliance: No |
| Severity Score: 37.5 | | | |

| Compliance | Description | Data | Compliance | Description | Data |
|---|---|---|---|---|---|
| N/A | Ramp Length (in) | 107.0 | No | Ramp Slope (%) | 14.5 |
| Yes | Ramp Width (in) | 48.0 | No | Ramp XSlope (%) | 6.4 |

**Remove & Replace Curb Ramp With Two New Directional Ramps or Equivalent.**

**R304.2.2, R304.5.3**
