Access Compliance Report

Public Rights-of-Way (Curb Ramps)

Intersection ID: 2777	Main Street: PIPESTONE_LN	Cross Street: SKYLINE_DR	Location: SW
ADA ID: D5EA97B71399	Ramp Type: BlendTrans1	Initial Pass/Fail: Fail	Overall Compliance: No
			Severity Score: 33.75

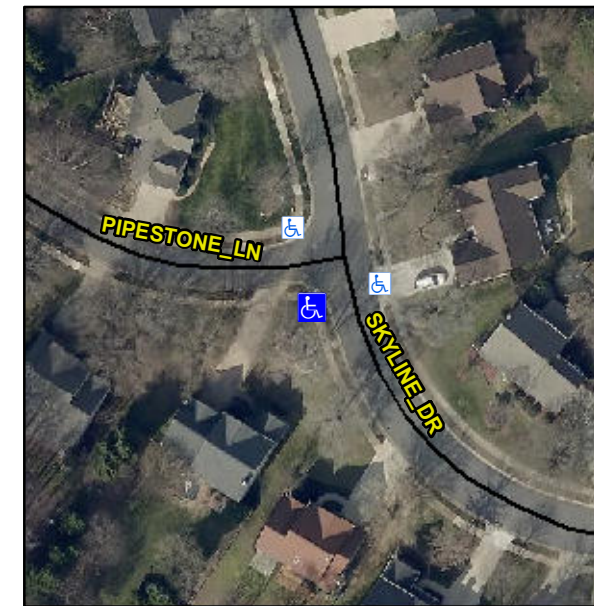
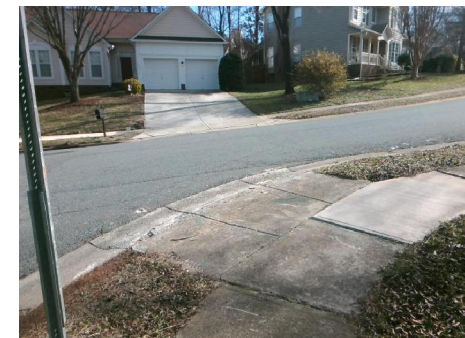
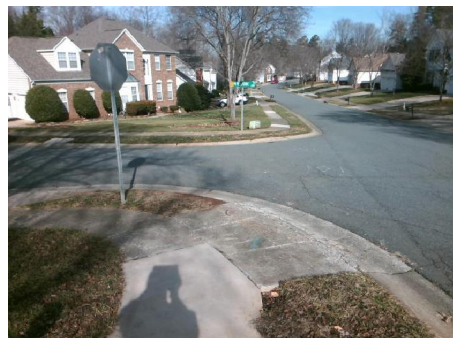
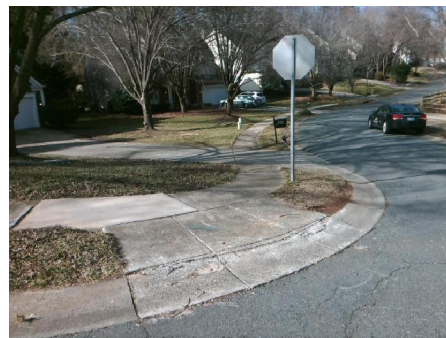
DAMAGED GTR

Not Found, R304.5.1, R304.5.3

Compliance	Description	Data	Compliance	Description	Data
N/A	Ramp Length (in)	48.0	Yes	BlendTrans Slope (%)	3.9
No	Ramp Width (in)	38.0	No	BlendTrans XSlope (%)	11.7
N/A	Flare Type LT	N/A	N/A	Flare Type RT	N/A
N/A	Flare Slope LT (%)	N/A	N/A	Flare Slope RT (%)	N/A
N/A	Flare Traversable LT?	N/A	N/A	Flare Traversable RT?	N/A
N/A	Landing Length (in)	N/A	N/A	DWS Provided?	N/A
N/A	Landing Width (in)	N/A	N/A	DWS Contrast?	N/A
N/A	Landing Slope (%)	N/A	N/A	DWS Length (in)	N/A
N/A	Landing X Slope (%)	N/A	N/A	DWS Full Width?	N/A
N/A	Landing Curb? (Y/N)	N/A	N/A	DWS Offset (in)	N/A
N/A	Shared Landing?	N/A			
N/A	Gutter Ponding?	N/A	N/A	Gutter Slope (%)	N/A
N/A	Gutter Lip Ht (in)	N/A	N/A	Gutter X Slope (%)	N/A
N/A	Painted X Walk1?	No	N/A	Painted X Walk2?	No
	X Walk 1 Direction	To NE		X Walk 2 Direction	To NW
	X Walk 1 Width (in)	N/A		X Walk 2 Width (in)	N/A
	X Walk 1 Slope (%)	1.6		X Walk 2 Slope (%)	7.6
	X Walk 1 X Slope (%)	7.5		X Walk 2 X Slope (%)	4.0

N/A	Ramp inside XWalk1?	N/A	N/A	Ramp inside XWalk2?	N/A
	Road Slope (%)	10.7		Clear Space?	N/A
	Road X Slope (%)	2.0	N/A	Clear Space to XWalk (in)	N/A
N/A	Any Obstructions?	N/A	N/A	Storm Grate/Utility Hazard?	N/A
	Obstruction Type			Storm Grate/Utility Type	
		N/A			N/A
			Yes	Surface Condition? (G/P)	Good
			No	Curb Slope (%)	12.5

Remove & Replace Curb Ramp With Two New Directional Ramps or Equivalent.
