Access Compliance Report

Public Rights-of-Way

(Curb Ramps)

Intersection ID: 31738	Main Street: LEAF_PLUM_DR	Cross Street: SAWLEAF_CT	Location: SW
ADA ID: D5F7287FE4F1	Ramp Type: PerpDiag	Initial Pass/Fail: Pass	Overall Compliance: No
Severity Score: 12.5			
Codes/Mitigation Info/Possible Solution		Field Measurements/Component Compliance

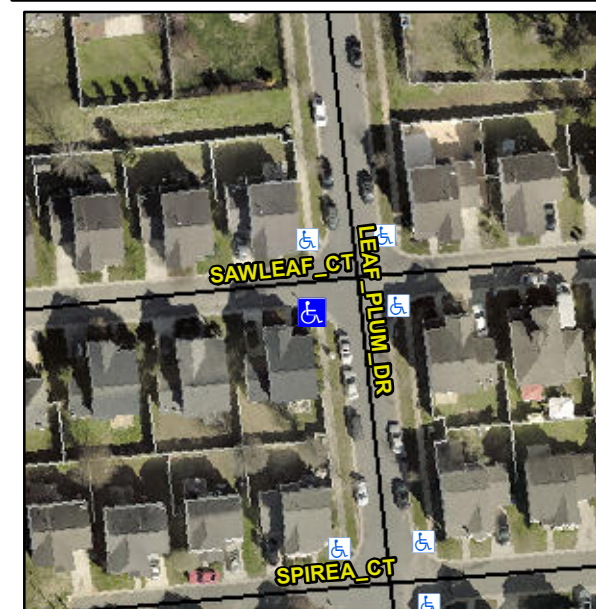
Compliance	Description	Data	Compliance	Description	Data
N/A	Ramp Length (in)	52.0	Yes	Ramp Slope (%)	5.5
Yes	Ramp Width (in)	48.0	Yes	Ramp XSlope (%)	1.3
N/A	Flare Type LT	Sloped	N/A	Flare Type RT	N/A
N/A	Flare Slope LT (%)	5.2	N/A	Flare Slope RT (%)	2.2
N/A	Flare Traversable LT?	No	N/A	Flare Traversable RT?	No
No	Landing Length (in)	38.0	Yes	DWS Provided?	Yes
Yes	Landing Width (in)	49.0	Yes	DWS Contrast?	Yes
No	Landing Slope (%)	2.7	Yes	DWS Length (in)	24.5
Yes	Landing X Slope (%)	1.1	Yes	DWS Full Width?	Yes
N/A	Landing Curb? (Y/N)	No	No	DWS Offset (in)	3.0
N/A	Shared Landing?	Yes			
No	Gutter Ponding?	Yes	No	Gutter Slope (%)	9.5
No	Gutter Lip Ht (in)	0.5	Yes	Gutter X Slope (%)	1.3
N/A	Painted X Walk1?	No	N/A	Painted X Walk2?	No
	X Walk 1 Direction	To E		X Walk 2 Direction	To N
N/A	X Walk 1 Width (in)	N/A	N/A	X Walk 2 Width (in)	N/A
	X Walk 1 Slope (%)	5.1		X Walk 2 Slope (%)	7.8
	X Walk 1 X Slope (%)	3.9		X Walk 2 X Slope (%)	2.4

N/A	Ramp inside XWalk1?	N/A	N/A	Ramp inside XWalk2?	N/A
	Road Slope (%)	1.4	N/A	Clear Space?	Yes
	Road X Slope (%)	5.6	N/A	Clear Space to XWalk (in)	N/A
Yes	Any Obstructions?	No	Yes	Storm Grate/Utility Hazard?	No
	Obstruction Type			Storm Grate/Utility Type	
		N/A			N/A
		Yes		Surface Condition? (G/P)	Good

Possible Solutions:

Remove & Replace Curb Ramp With Two New Directional Ramps or Equivalent. Remove & Replace Gutter.

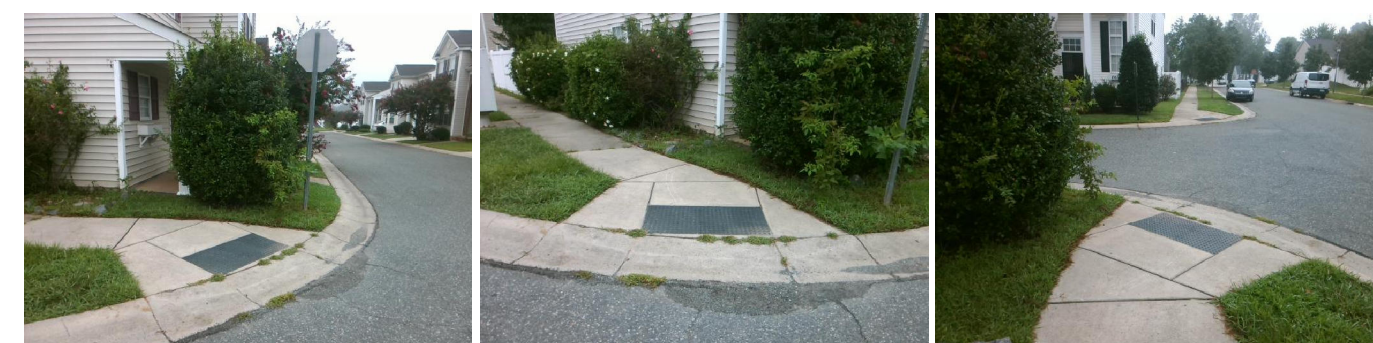
Not Found, R304.2.1, R304.2.2-Perp, R304.3.2-Para, R305.2, R302.7, R302.7.2, R304.5.4
