Access Compliance Report

Public Rights-of-Way

(Curb Ramps)

| Intersection ID: 16161 | Main Street: E_INDEPENDENCE_BV | Cross Street: CHARLESTON DR | Location: | N |

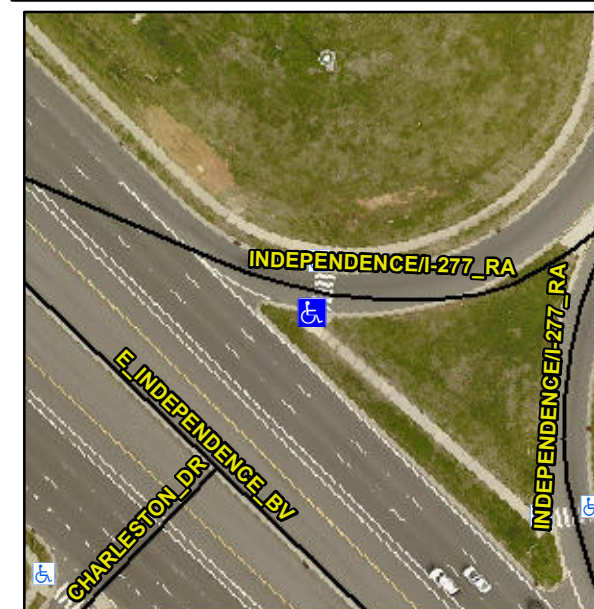
| ADA ID: D5F88942DFED | Ramp Type: Perp | Initial Pass/Fail: Fail | Overall Compliance: No | Severity Score: 12.5 |

Not Found, R304.2.2

| Compliance | Description | Data | Compliance | Description | Data |
|---|---|---|---|---|---|
| N/A | Ramp Length (in) | 72.0 | No | Ramp Slope (%) | 8.6 |

Possible Solutions:

Remove & Replace Entire Ramp.
