# Access Compliance Report

## Public Rights-of-Way

### (Curb Ramps)

Intersection ID: 14251	Main Street: CHESTERFIELD_AV	Cross Street: LORNA_ST	Location: N
ADA ID: D5F9DCE09055	Ramp Type: PerpDiag	Initial Pass/Fail: Fail	Overall Compliance: No
Severity Score: 12.5			
Codes/Mitigation Info/Possible Solution		Field Measurements/Component Compliance

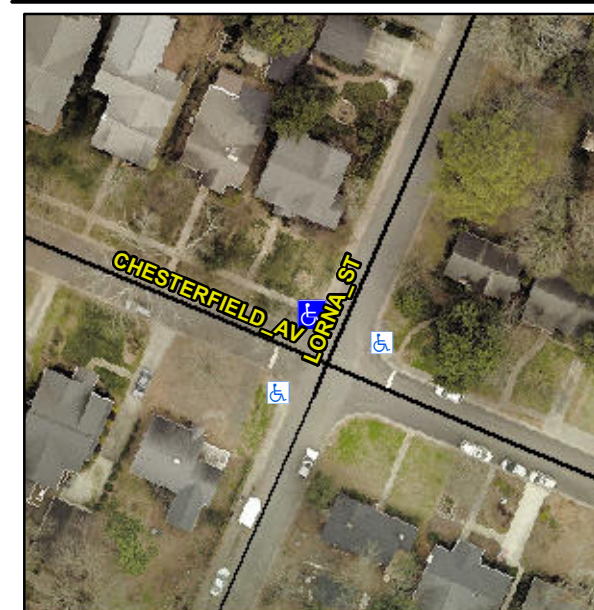
Compliance	Description	Data	Compliance	Description	Data
N/A	Ramp Length (in)	62.0	No	Ramp Slope (%)	8.7
Yes	Ramp Width (in)	87.0	Yes	Ramp XSlope (%)	0.4
N/A	Flare Type LT	N/A	N/A	Flare Type RT	N/A
N/A	Flare Slope LT (%)	N/A	N/A	Flare Slope RT (%)	N/A
N/A	Flare Traversable LT?	N/A	N/A	Flare Traversable RT?	N/A
N/A	Landing Length (in)	N/A	N/A	DWS Provided?	N/A
N/A	Landing Width (in)	N/A	N/A	DWS Contrast?	N/A
N/A	Landing Slope (%)	N/A	N/A	DWS Length (in)	N/A
N/A	Landing X Slope (%)	N/A	N/A	DWS Full Width?	N/A
N/A	Landing Curb? (Y/N)	N/A	N/A	DWS Offset (in)	N/A
N/A	Shared Landing?	N/A			
N/A	Gutter Ponding?	Yes	N/A	Gutter Slope (%)	N/A
N/A	Gutter Lip Ht (in)	N/A	N/A	Gutter X Slope (%)	N/A
N/A	Painted X Walk1?	No	N/A	Painted X Walk2?	No
	X Walk 1 Direction	To SW		X Walk 2 Direction	To SE
N/A	X Walk 1 Width (in)	N/A	N/A	X Walk 2 Width (in)	N/A
	X Walk 1 Slope (%)	5.0		X Walk 2 Slope (%)	3.9
	X Walk 1 X Slope (%)	1.2		X Walk 2 X Slope (%)	0.5

N/A	Ramp inside XWalk1?	N/A	N/A	Ramp inside XWalk2?	N/A
	Road Slope (%)	0.5	N/A	Clear Space?	N/A
	Road X Slope (%)	3.6	N/A	Clear Space to XWalk (in)	N/A
N/A	Any Obstructions?	N/A	N/A	Storm Grate/Utility Hazard?	N/A
	Obstruction Type			Storm Grate/Utility Type	
		N/A			N/A
		Yes		Surface Condition? (G/P)	Good

**Remove & Replace Curb Ramp With Two New Directional Ramps or Equivalent.**
