Access Compliance Report

Public Rights-of-Way

(Curb Ramps)

Intersection ID: N/A	Main Street: ALLEGIANCE DR	Cross Street: TANYARD LN	Location:	N
ADA ID: D5FA0FBAB5E8	Ramp Type: PerpDiag	Initial Pass/Fail: Fail	Overall Compliance: No	Severity Score: 18.75
Codes/Mitigation Info/Possible Solution		Field Measurements/Component Compliance

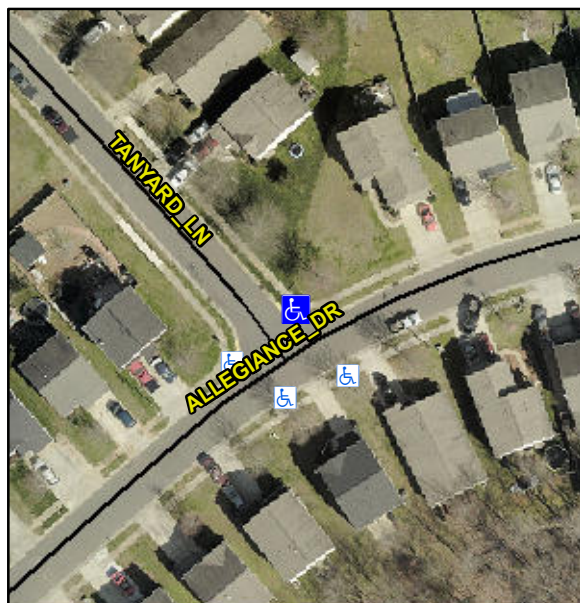
Compliance	Description	Data	Compliance	Description	Data
N/A	Ramp Length (in)	50.0	Yes	Ramp Slope (%)	5.5
No	Ramp Width (in)	34.0	No	Ramp XSlope (%)	3.5
N/A	Flare Type LT	N/A	N/A	Flare Type RT	N/A
N/A	Flare Slope LT (%)	N/A	N/A	Flare Slope RT (%)	N/A
N/A	Flare Traversable LT?	No	N/A	Flare Traversable RT?	No
N/A	Landing Length (in)	N/A	N/A	DWS Provided?	N/A
N/A	Landing Width (in)	N/A	N/A	DWS Contrast?	N/A
N/A	Landing Slope (%)	N/A	N/A	DWS Length (in)	N/A
N/A	Landing X Slope (%)	N/A	N/A	DWS Full Width?	N/A
N/A	Landing Curb? (Y/N)	N/A	N/A	DWS Offset (in)	N/A
N/A	Shared Landing?	N/A			
N/A	Gutter Ponding?	N/A	N/A	Gutter Slope (%)	N/A
N/A	Gutter Lip Ht (in)	N/A	N/A	Gutter X Slope (%)	N/A
N/A	Painted X Walk1?	No	N/A	Painted X Walk2?	No
	X Walk 1 Direction	To SW		X Walk 2 Direction	To SE
N/A	X Walk 1 Width (in)	N/A	N/A	X Walk 2 Width (in)	N/A
	X Walk 1 Slope (%)	1.7		X Walk 2 Slope (%)	1.3
	X Walk 1 X Slope (%)	2.9		X Walk 2 X Slope (%)	2.6

N/A	Ramp inside XWalk1?	No	N/A	Ramp inside XWalk2?	No
	Road Slope (%)	2.6	N/A	Clear Space?	N/A
	Road X Slope (%)	1.3	N/A	Clear Space to XWalk (in)	N/A
N/A	Any Obstructions?	N/A	N/A	Storm Grate/Utility Hazard?	N/A
	Obstruction Type			Storm Grate/Utility Type	
		N/A			N/A
			Yes	Surface Condition? (G/P)	Good

Possible Solutions:

Remove & Replace Curb Ramp With Two New Directional Ramps or Equivalent.

Not Found, R304.5.1, R304.5.3
