Access Compliance Report

Public Rights-of-Way

(Curb Ramps)

Intersection ID: 51310	Main Street: I-485_RA	Cross Street: W_W_T_HARRIS_BV	Location: NE
ADA ID: D5FC74892DB0	Ramp Type: Perp	Initial Pass/Fail: Fail	Overall Compliance: No
Severity Score: 13.75			
Codes/Mitigation Info/Possible Solution		Field Measurements/Component Compliance

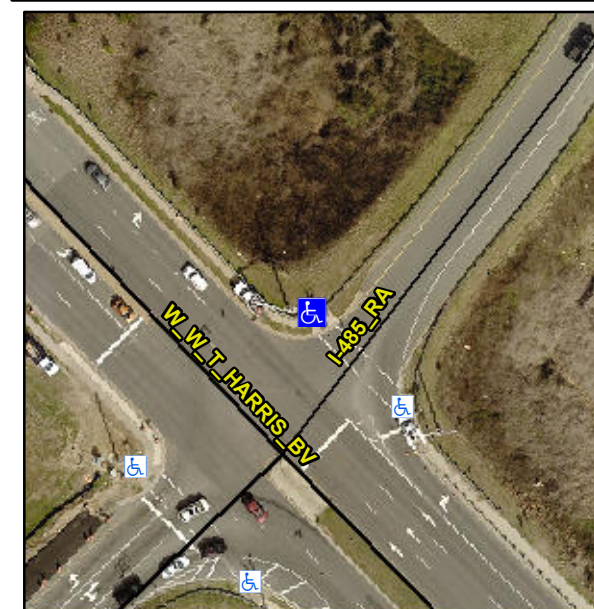
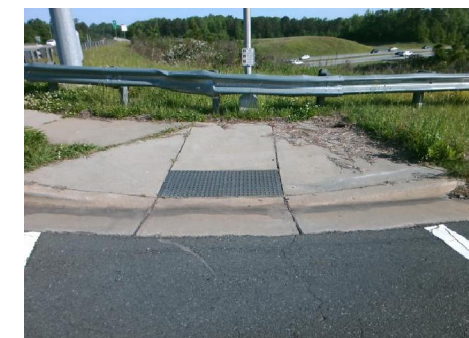
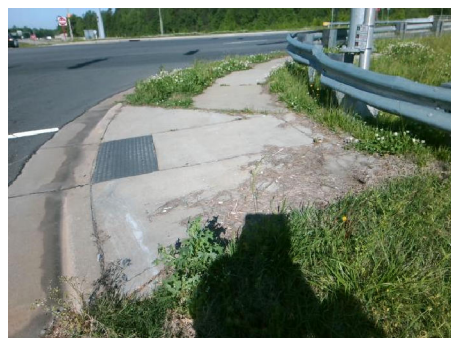
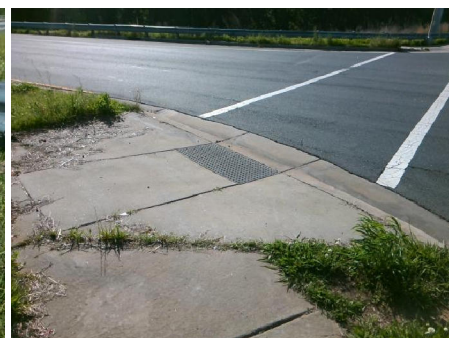
Compliance	Description	Data	Compliance	Description	Data
N/A	Ramp Length (in)	89.0	No	Ramp Slope (%)	8.5
Yes	Ramp Width (in)	48.0	Yes	Ramp XSlope (%)	2.9
N/A	Flare Type LT	N/A	N/A	Flare Type RT	N/A
N/A	Flare Slope LT (%)	N/A	N/A	Flare Slope RT (%)	N/A
N/A	Flare Traversable LT?	N/A	N/A	Flare Traversable RT?	N/A
N/A	Landing Length (in)	N/A	N/A	DWS Provided?	N/A
N/A	Landing Width (in)	N/A	N/A	DWS Contrast?	N/A
N/A	Landing Slope (%)	N/A	N/A	DWS Length (in)	N/A
N/A	Landing X Slope (%)	N/A	N/A	DWS Full Width?	N/A
N/A	Landing Curb? (Y/N)	N/A	N/A	DWS Offset (in)	N/A
N/A	Shared Landing?	N/A			
N/A	Gutter Ponding?	N/A	N/A	Gutter Slope (%)	N/A
N/A	Gutter Lip Ht (in)	N/A	N/A	Gutter X Slope (%)	N/A
N/A	Painted X Walk1?	Yes	N/A	Painted X Walk2?	N/A
	X Walk 1 Direction	To SE		X Walk 2 Direction	N/A
N/A	X Walk 1 Width (in)	113.0	N/A	X Walk 2 Width (in)	N/A
	X Walk 1 Slope (%)	0.4		X Walk 2 Slope (%)	N/A
	X Walk 1 X Slope (%)	3.6		X Walk 2 X Slope (%)	N/A

N/A	Ramp inside XWalk1?	Yes	N/A	Ramp inside XWalk2?	N/A
	Road Slope (%)	N/A	N/A	Clear Space?	N/A
	Road X Slope (%)	N/A	N/A	Clear Space to XWalk (in)	N/A
N/A	Any Obstructions?	N/A	N/A	Storm Grate/Utility Hazard?	N/A
	Obstruction Type			Storm Grate/Utility Type	
		N/A			N/A
			Yes	Surface Condition? (G/P)	Good

Possible Solutions:

Remove & Replace Entire Ramp.

R304.2.2

\$ 1850.00
