Access Compliance Report Public Rights-of-Way (Curb Ramps)

Intersection ID: 42675 Main Street: WALLACE_CABIN_DR Cross Street: WALLACE_GLEN_DR Location: NW
ADA ID: D6061B47964C Ramp Type: PerpDiag Initial Pass/Fail: Fail Overall Compliance: No Severity Score: 8.75

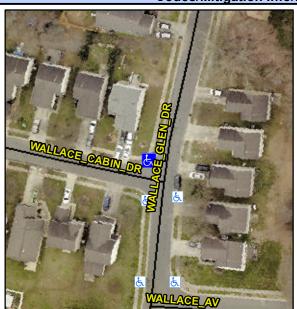
Compliance Description Data Compliance Description Data Yes N/A Ramp Length (in) 49.0 Ramp Slope (%) 7.2 Yes Ramp XSlope (%) No Ramp Width (in) 36.5 1.7 N/A N/A Flare Type LT N/A Flare Type RT N/A N/A N/A N/A Flare Slope RT (%) N/A Flare Slope LT (%) N/A Flare Traversable LT? N/A N/A Flare Traversable RT? N/A N/A N/A N/A DWS Provided? N/A Landing Length (in) N/A Landing Width (in) N/A N/A **DWS Contrast?** N/A N/A N/A N/A Landing Slope (%) DWS Length (in) N/A N/A Landing X Slope (%) N/A N/A DWS Full Width? N/A N/A Landing Curb? (Y/N) N/A N/A DWS Offset (in) N/A N/A N/A Shared Landing? N/A **Gutter Ponding?** N/A Gutter Slope (%) N/A Yes N/A Gutter Lip Ht (in) N/A N/A Gutter X Slope (%) N/A N/A Painted X Walk1? No N/A Painted X Walk2? No X Walk 1 Direction To S X Walk 2 Direction To E N/A N/A X Walk 2 Width (in) X Walk 1 Width (in) N/A X Walk 1 Slope (%) 1.8 X Walk 2 Slope (%) 4.6 X Walk 2 X Slope (%) X Walk 1 X Slope (%) 2.3 0.2 N/A N/A N/A Ramp inside XWalk2? N/A Ramp inside XWalk1? Road Slope (%) 0.9 N/A Clear Space? N/A N/A Road X Slope (%) 2.1 Clear Space to XWalk (in) N/A N/A N/A N/A Any Obstructions? Storm Grate/Utility Hazard? N/A **Obstruction Type** Storm Grate/Utility Type N/A N/A Yes Surface Condition? (G/P) Good

Remove & Replace Curb Ramp With
Two New Directional Ramps or
Equivalent.

R304.5.1
