Access Compliance Report

Public Rights-of-Way

(Curb Ramps)

Intersection ID: 44210	Main Street: MOCKERNUT_DR	Cross Street: PINACEAL_CT	Location: SE
ADA ID: D607C9B9260B	Ramp Type: PerpDiag	Initial Pass/Fail: Fail	Overall Compliance: No
		Severity Score: 12.5

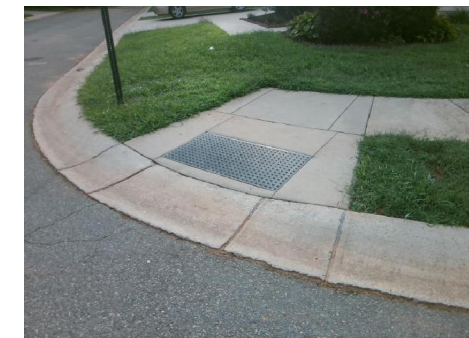
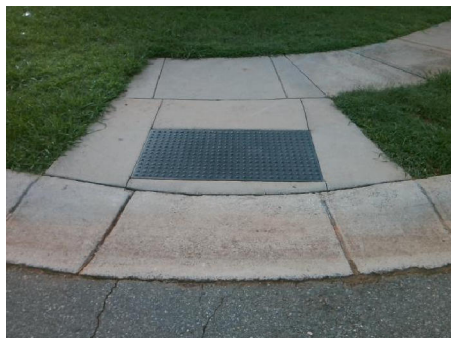
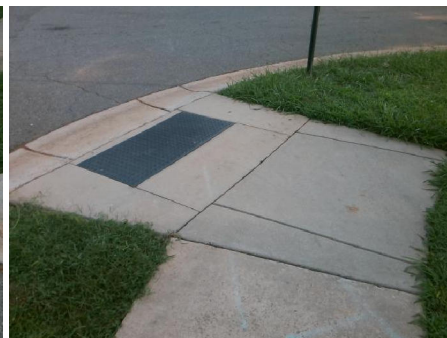
Compliance	Description	Data	Compliance	Description	Data
N/A	Ramp Length (in)	50.5	Yes	Ramp Slope (%)	6.0
Yes	Ramp Width (in)	48.0	No	Ramp XSlope (%)	6.6
N/A	Flare Type LT	N/A	N/A	Flare Type RT	N/A
N/A	Flare Slope LT (%)	N/A	N/A	Flare Slope RT (%)	N/A
N/A	Flare Traversable LT?	N/A	N/A	Flare Traversable RT?	N/A
N/A	Landing Length (in)	N/A	N/A	DWS Provided?	N/A
N/A	Landing Width (in)	N/A	N/A	DWS Contrast?	N/A
N/A	Landing Slope (%)	N/A	N/A	DWS Length (in)	N/A
N/A	Landing X Slope (%)	N/A	N/A	DWS Full Width?	N/A
N/A	Landing Curb? (Y/N)	N/A	N/A	DWS Offset (in)	N/A
N/A	Shared Landing?	N/A			
N/A	Gutter Ponding?	N/A	N/A	Gutter Slope (%)	N/A
N/A	Gutter Lip Ht (in)	N/A	N/A	Gutter X Slope (%)	N/A
N/A	Painted X Walk1?	No	N/A	Painted X Walk2?	No
	X Walk 1 Direction	To N		X Walk 2 Direction	To W
N/A	X Walk 1 Width (in)	N/A	N/A	X Walk 2 Width (in)	N/A
	X Walk 1 Slope (%)	0.5		X Walk 2 Slope (%)	3.8
	X Walk 1 X Slope (%)	3.4		X Walk 2 X Slope (%)	2.1

N/A	Ramp inside XWalk1?	N/A	N/A	Ramp inside XWalk2?	N/A
	Road Slope (%)	6.5	N/A	Clear Space?	N/A
	Road X Slope (%)	4.1	N/A	Clear Space to XWalk (in)	N/A
N/A	Any Obstructions?	N/A	N/A	Storm Grate/Utility Hazard?	N/A
	Obstruction Type			Storm Grate/Utility Type	
		N/A			N/A
		Yes		Surface Condition? (G/P)	Good

Remove & Replace Curb Ramp With Two New Directional Ramps or Equivalent.

Not Found, R304.5.3
