Access Compliance Report

Public Rights-of-Way

(Curb Ramps)

Intersection ID: 50008	Main Street: BERKELEY_PLACE_DR	Cross Street: SALERNO_DR	Location: S
ADA ID: D62B15850FA7	Ramp Type: PerpDiag	Initial Pass/Fail: Fail	Overall Compliance: No
Severity Score: 33.75			
Codes/Mitigation Info/Possible Solution		Field Measurements/Component Compliance

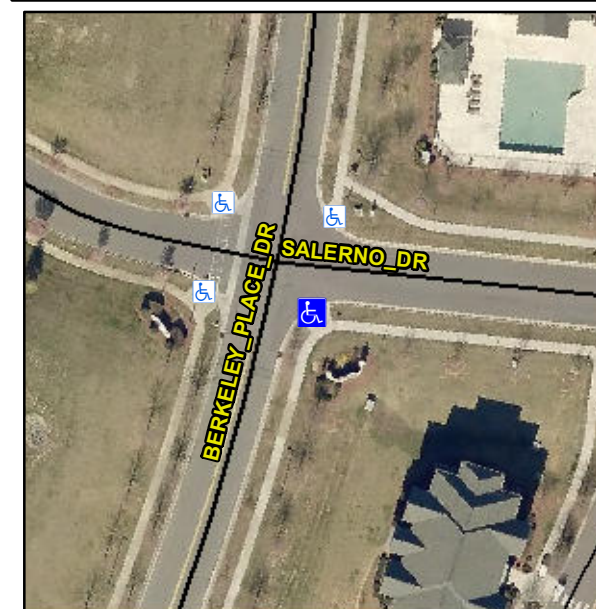
R304.5.1, R304.2.2, R304.5.3

Compliance	Description	Data	Compliance	Description	Data
N/A	Ramp Length (in)	98.0	No	Ramp Slope (%)	9.0
No	Ramp Width (in)	46.2	No	Ramp XSlope (%)	6.9
N/A	Flare Type LT	N/A	N/A	Flare Type RT	N/A
N/A	Flare Slope LT (%)	N/A	N/A	Flare Slope RT (%)	N/A
N/A	Flare Traversable LT?	N/A	N/A	Flare Traversable RT?	N/A
N/A	Landing Length (in)	N/A	N/A	DWS Provided?	N/A
N/A	Landing Width (in)	N/A	N/A	DWS Contrast?	N/A
N/A	Landing Slope (%)	N/A	N/A	DWS Length (in)	N/A
N/A	Landing X Slope (%)	N/A	N/A	DWS Full Width?	N/A
N/A	Landing Curb? (Y/N)	N/A	N/A	DWS Offset (in)	N/A
N/A	Shared Landing?	N/A			
N/A	Gutter Ponding?	N/A	N/A	Gutter Slope (%)	N/A
N/A	Gutter Lip Ht (in)	N/A	N/A	Gutter X Slope (%)	N/A
N/A	Painted X Walk1?	No	N/A	Painted X Walk2?	No
	X Walk 1 Direction	To NE		X Walk 2 Direction	To NW
N/A	X Walk 1 Width (in)	N/A	N/A	X Walk 2 Width (in)	N/A
	X Walk 1 Slope (%)	0.4		X Walk 2 Slope (%)	7.7
	X Walk 1 X Slope (%)	6.9		X Walk 2 X Slope (%)	0.5

N/A	Ramp inside XWalk1?	N/A	N/A	Ramp inside XWalk2?	N/A
	Road Slope (%)	7.1	N/A	Clear Space?	N/A
	Road X Slope (%)	3.9	N/A	Clear Space to XWalk (in)	N/A
N/A	Any Obstructions?	N/A	N/A	Storm Grate/Utility Hazard?	N/A
	Obstruction Type			Storm Grate/Utility Type	
		N/A			N/A
			Yes	Surface Condition? (G/P)	Good

Possible Solutions:

Remove & Replace Curb Ramp With Two New Directional Ramps or Equivalent.
