# Access Compliance Report

## Public Rights-of-Way

### (Curb Ramps)

| Intersection ID: 19093 | Main Street: BRAEBURN_RD | Cross Street: GATE_POST_RD | Location: | N |

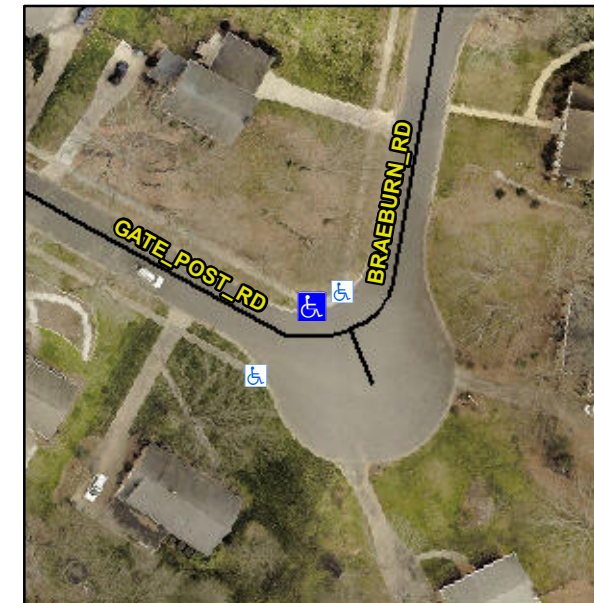
| ADA ID: D62D0BA5104F | Ramp Type: Perp | Initial Pass/Fail: Fail | Overall Compliance: No | Severity Score: 25 |

**Not Found, R304.5.3**

| Compliance | Description | Data | Compliance | Description | Data |
|---|---|---|---|---|---|
| Yes | Ramp Width (in) | 48.0 | No | Ramp XSlope (%) | 12.5 |

**Remove & Replace Entire Ramp.**
