# Access Compliance Report

## Public Rights-of-Way

### (Curb Ramps)

| Intersection ID: 32250 | Main Street: DARCY_HOPKINS_DR | Cross Street: DENNINGTON_GROVE_LN | Location: S |

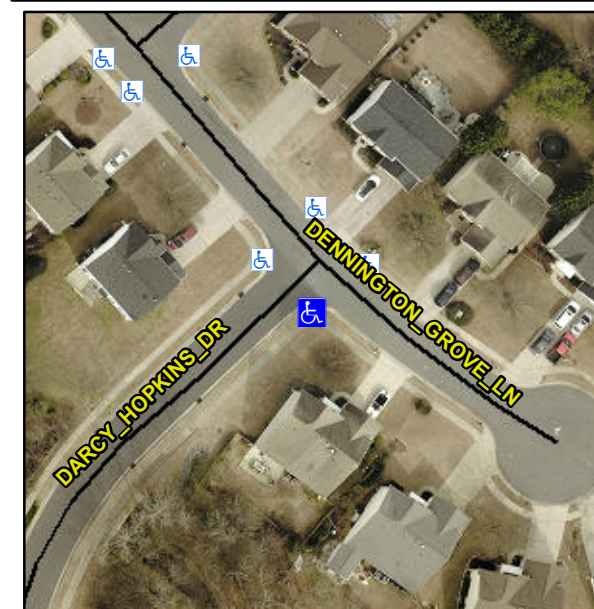
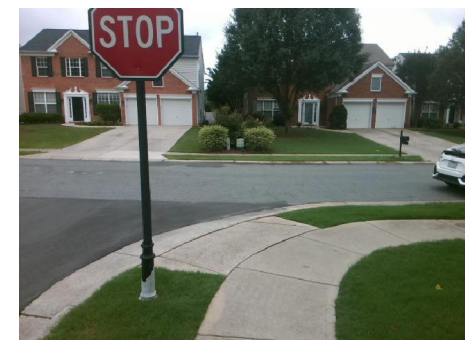
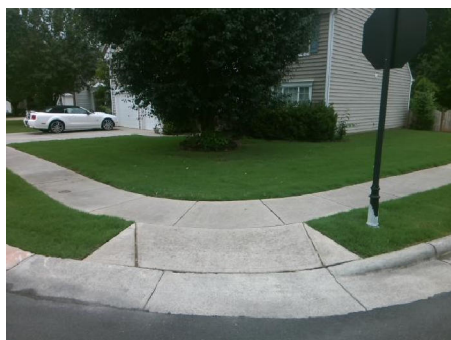
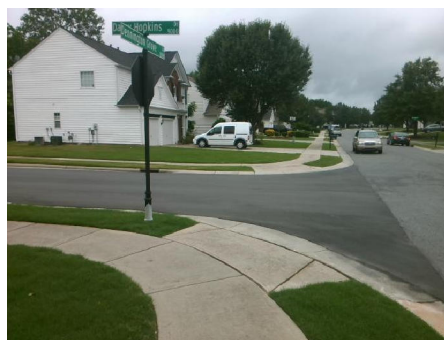
| ADA ID: D62D190EF1A6 | Ramp Type: BlendTrans1 | Initial Pass/Fail: Pass | Overall Compliance: No |

**Not Found, R304.2.2-Perp, R304.3.2-Para, R305**

| Compliance | Description | Data | Compliance | Description | Data |
|---|---|---|---|---|---|
| Yes | Landing Length (in) | 49.0 | No | DWS Provided? | No |
| No | Landing Slope (%) | 2.7 | N/A | DWS Length (in) | N/A |
| | | | No | Curb Slope (%) | 14.7 |

**Remove & Replace Curb Ramp With Two New Directional Ramps or Equivalent.**

Total Cost: \$ 3200.00
