# Access Compliance Report

## Public Rights-of-Way

### (Curb Ramps)

Intersection ID: 14429	Main Street: LEAKE_ST	Cross Street: WEST_BV	Location: NE
ADA ID: D62D7DCFBF1E	Ramp Type: PerpDiag	Initial Pass/Fail: Fail	Overall Compliance: No
		Severity Score: 37.5

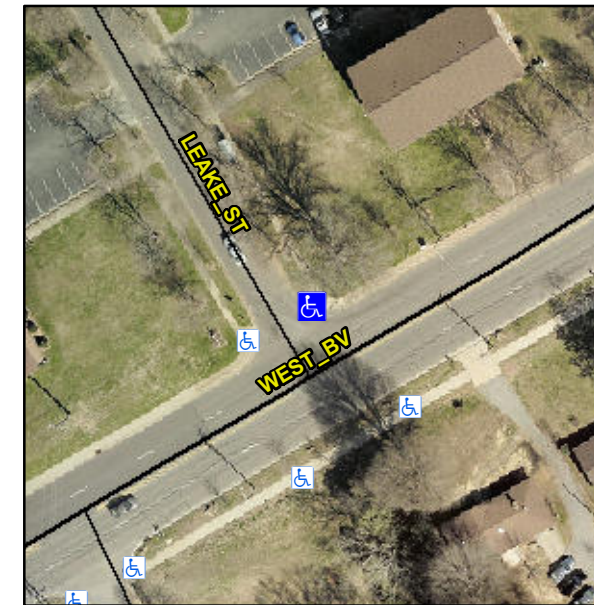
**Not Found, R304.2.2, R304.5.3**

Compliance	Description	Data	Compliance	Description	Data
N/A	Ramp Length (in)	94.0	No	Ramp Slope (%)	14.6
Yes	Ramp Width (in)	48.0	No	Ramp XSlope (%)	6.3
N/A	Flare Type LT	N/A	N/A	Flare Type RT	N/A
N/A	Flare Slope LT (%)	N/A	N/A	Flare Slope RT (%)	N/A
N/A	Flare Traversable LT?	N/A	N/A	Flare Traversable RT?	N/A
N/A	Landing Length (in)	N/A	N/A	DWS Provided?	N/A
N/A	Landing Width (in)	N/A	N/A	DWS Contrast?	N/A
N/A	Landing Slope (%)	N/A	N/A	DWS Length (in)	N/A
N/A	Landing X Slope (%)	N/A	N/A	DWS Full Width?	N/A
N/A	Landing Curb? (Y/N)	N/A	N/A	DWS Offset (in)	N/A
N/A	Shared Landing?	N/A			
N/A	Gutter Ponding?	N/A	N/A	Gutter Slope (%)	N/A
N/A	Gutter Lip Ht (in)	0.5	N/A	Gutter X Slope (%)	N/A
N/A	Painted X Walk1?	No	N/A	Painted X Walk2?	No
	X Walk 1 Direction	To SW		X Walk 2 Direction	To SE
N/A	X Walk 1 Width (in)	N/A	N/A	X Walk 2 Width (in)	N/A
	X Walk 1 Slope (%)	1.6		X Walk 2 Slope (%)	3.2
	X Walk 1 X Slope (%)	3.0		X Walk 2 X Slope (%)	1.9

N/A	Ramp inside XWalk1?	N/A	N/A	Ramp inside XWalk2?	N/A
	Road Slope (%)	2.8	N/A	Clear Space?	N/A
	Road X Slope (%)	2.4	N/A	Clear Space to XWalk (in)	N/A
N/A	Any Obstructions?	N/A	N/A	Storm Grate/Utility Hazard?	N/A
	Obstruction Type			Storm Grate/Utility Type	
		N/A			N/A
			Yes	Surface Condition? (G/P)	Good

**Remove & Replace Curb Ramp With Two New Directional Ramps or Equivalent.**
