Access Compliance Report

Public Rights-of-Way

(Curb Ramps)

Intersection ID: 11051	Main Street: E_21ST_ST	Cross Street: N_BREVARD_ST	Location: S
ADA ID: D62DB90C1FD3	Ramp Type: PerpDiag	Initial Pass/Fail: Fail	Overall Compliance: No
Severity Score: 22.5			
Codes/Mitigation Info/Possible Solution		Field Measurements/Component Compliance

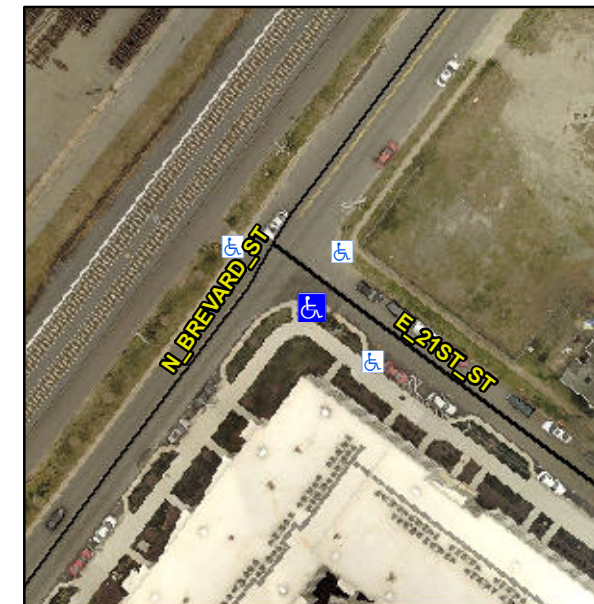
R304.5.1, R304.2.2, R304.5.3

Compliance	Description	Data	Compliance	Description	Data
N/A	Ramp Length (in)	92.0	No	Ramp Slope (%)	8.5
No	Ramp Width (in)	47.0	No	Ramp XSlope (%)	2.3
N/A	Flare Type LT	N/A	N/A	Flare Type RT	N/A
N/A	Flare Slope LT (%)	N/A	N/A	Flare Slope RT (%)	N/A
N/A	Flare Traversable LT?	N/A	N/A	Flare Traversable RT?	N/A
N/A	Landing Length (in)	N/A	N/A	DWS Provided?	N/A
N/A	Landing Width (in)	N/A	N/A	DWS Contrast?	N/A
N/A	Landing Slope (%)	N/A	N/A	DWS Length (in)	N/A
N/A	Landing X Slope (%)	N/A	N/A	DWS Full Width?	N/A
N/A	Landing Curb? (Y/N)	N/A	N/A	DWS Offset (in)	N/A
N/A	Shared Landing?	N/A			
N/A	Gutter Ponding?	N/A	N/A	Gutter Slope (%)	N/A
N/A	Gutter Lip Ht (in)	N/A	N/A	Gutter X Slope (%)	N/A
N/A	Painted X Walk1?	No	N/A	Painted X Walk2?	No
	X Walk 1 Direction	To NE		X Walk 2 Direction	To NW
N/A	X Walk 1 Width (in)	N/A	N/A	X Walk 2 Width (in)	N/A
	X Walk 1 Slope (%)	0.4		X Walk 2 Slope (%)	2.8
	X Walk 1 X Slope (%)	1.9		X Walk 2 X Slope (%)	0.3

N/A	Ramp inside XWalk1?	N/A	N/A	Ramp inside XWalk2?	N/A
	Road Slope (%)	1.5	N/A	Clear Space?	N/A
	Road X Slope (%)	4.7	N/A	Clear Space to XWalk (in)	N/A
N/A	Any Obstructions?	N/A	N/A	Storm Grate/Utility Hazard?	N/A
	Obstruction Type			Storm Grate/Utility Type	
		N/A			N/A
			Yes	Surface Condition? (G/P)	Good

Remove & Replace Curb Ramp With Two New Directional Ramps or Equivalent.
