# Access Compliance Report

## Public Rights-of-Way

### (Curb Ramps)

Intersection ID: 47116	Main Street: MCKEE_FOREST_CT	Cross Street: CARPENTER_CABIN_DR	Location: SE
ADA ID: D63094D9C2A0	Ramp Type: PerpDiag	Initial Pass/Fail: Fail	Overall Compliance: No
		Severity Score: 12.5

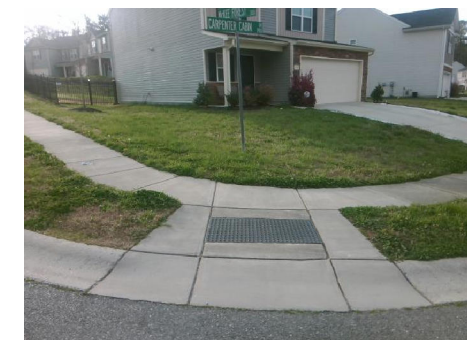
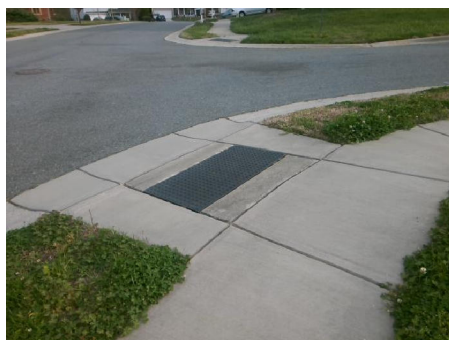
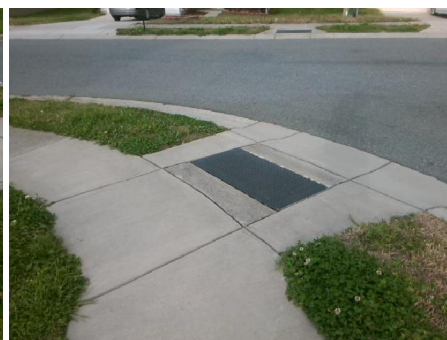
Compliance	Description	Data	Compliance	Description	Data
N/A	Ramp Length (in)	48.0	Yes	Ramp Slope (%)	5.1
Yes	Ramp Width (in)	48.0	No	Ramp XSlope (%)	5.2
N/A	Flare Type LT	N/A	N/A	Flare Type RT	N/A
N/A	Flare Slope LT (%)	N/A	N/A	Flare Slope RT (%)	N/A
N/A	Flare Traversable LT?	N/A	N/A	Flare Traversable RT?	N/A
N/A	Landing Length (in)	N/A	N/A	DWS Provided?	N/A
N/A	Landing Width (in)	N/A	N/A	DWS Contrast?	N/A
N/A	Landing Slope (%)	N/A	N/A	DWS Length (in)	N/A
N/A	Landing X Slope (%)	N/A	N/A	DWS Full Width?	N/A
N/A	Landing Curb? (Y/N)	N/A	N/A	DWS Offset (in)	N/A
N/A	Shared Landing?	N/A			
N/A	Gutter Ponding?	N/A	N/A	Gutter Slope (%)	N/A
N/A	Gutter Lip Ht (in)	N/A	N/A	Gutter X Slope (%)	N/A
N/A	Painted X Walk1?	No	N/A	Painted X Walk2?	No
	X Walk 1 Direction	To N		X Walk 2 Direction	To W
N/A	X Walk 1 Width (in)	N/A	N/A	X Walk 2 Width (in)	N/A
	X Walk 1 Slope (%)	4.6		X Walk 2 Slope (%)	2.1
	X Walk 1 X Slope (%)	1.0		X Walk 2 X Slope (%)	5.1

N/A	Ramp inside XWalk1?	N/A	N/A	Ramp inside XWalk2?	N/A
	Road Slope (%)	4.2	N/A	Clear Space?	N/A
	Road X Slope (%)	4.7	N/A	Clear Space to XWalk (in)	N/A
N/A	Any Obstructions?	N/A	N/A	Storm Grate/Utility Hazard?	N/A
	Obstruction Type			Storm Grate/Utility Type	
		N/A			N/A
			Yes	Surface Condition? (G/P)	Good

**Remove & Replace Curb Ramp With Two New Directional Ramps or Equivalent.**
