Access Compliance Report

Public Rights-of-Way

(Curb Ramps)

Intersection ID: 16407	Main Street: PORTLAND_AV	Cross Street: PROVIDENCE_RD	Location: SW
ADA ID: D6312E34B67A	Ramp Type: BlendTrans1	Initial Pass/Fail: Fail	Overall Compliance: No
		Severity Score: 12.5

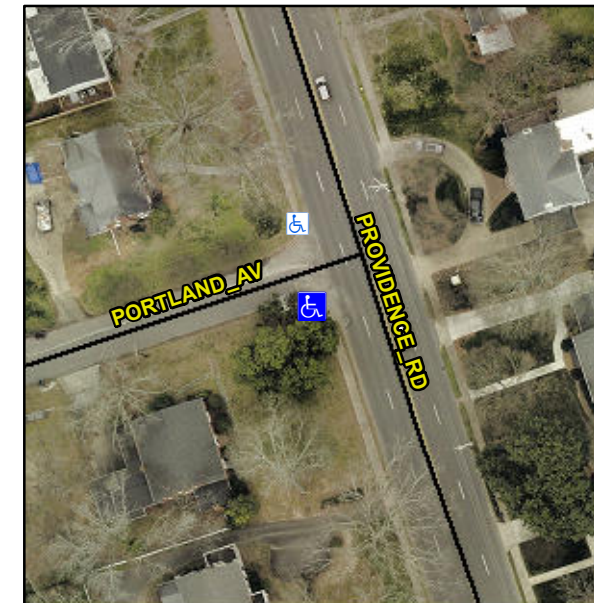
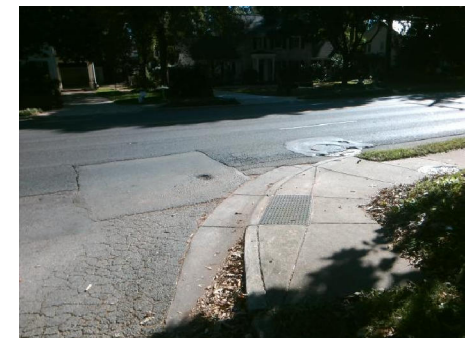
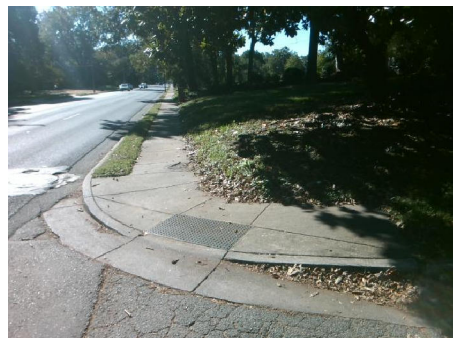
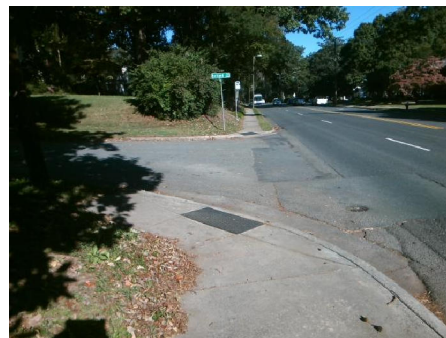
Not Found, R304.5.3

Compliance	Description	Data	Compliance	Description	Data
N/A	Ramp Length (in)	25.0	Yes	BlendTrans Slope (%)	4.7
Yes	Ramp Width (in)	48.0	No	BlendTrans XSlope (%)	6.1
N/A	Flare Type LT	N/A	N/A	Flare Type RT	N/A
N/A	Flare Slope LT (%)	N/A	N/A	Flare Slope RT (%)	N/A
N/A	Flare Traversable LT?	N/A	N/A	Flare Traversable RT?	N/A
N/A	Landing Length (in)	N/A	N/A	DWS Provided?	N/A
N/A	Landing Width (in)	N/A	N/A	DWS Contrast?	N/A
N/A	Landing Slope (%)	N/A	N/A	DWS Length (in)	N/A
N/A	Landing X Slope (%)	N/A	N/A	DWS Full Width?	N/A
N/A	Landing Curb? (Y/N)	N/A	N/A	DWS Offset (in)	N/A
N/A	Shared Landing?	N/A			
N/A	Gutter Ponding?	N/A	N/A	Gutter Slope (%)	N/A
N/A	Gutter Lip Ht (in)	N/A	N/A	Gutter X Slope (%)	N/A
N/A	Painted X Walk1?	No	N/A	Painted X Walk2?	No
	X Walk 1 Direction	To E		X Walk 2 Direction	To N
	X Walk 1 Width (in)	N/A		X Walk 2 Width (in)	N/A
	X Walk 1 Slope (%)	3.0		X Walk 2 Slope (%)	4.8
	X Walk 1 X Slope (%)	2.2		X Walk 2 X Slope (%)	1.2

N/A	Ramp inside XWalk1?	N/A	N/A	Ramp inside XWalk2?	N/A
	Road Slope (%)	5.1		Clear Space?	N/A
	Road X Slope (%)	3.2	N/A	Clear Space to XWalk (in)	N/A
N/A	Any Obstructions?	N/A	N/A	Storm Grate/Utility Hazard?	N/A
	Obstruction Type			Storm Grate/Utility Type	
		N/A			N/A
			Yes	Surface Condition? (G/P)	Good
			No	Curb Slope (%)	7.1

Remove & Replace Curb Ramp With Two New Directional Ramps or Equivalent.
