# Access Compliance Report

## Public Rights-of-Way

### (Curb Ramps)

| Intersection ID: 9265 | Main Street: GLENWOOD_DR | Cross Street: PRITCHARD_ST | Location: W |

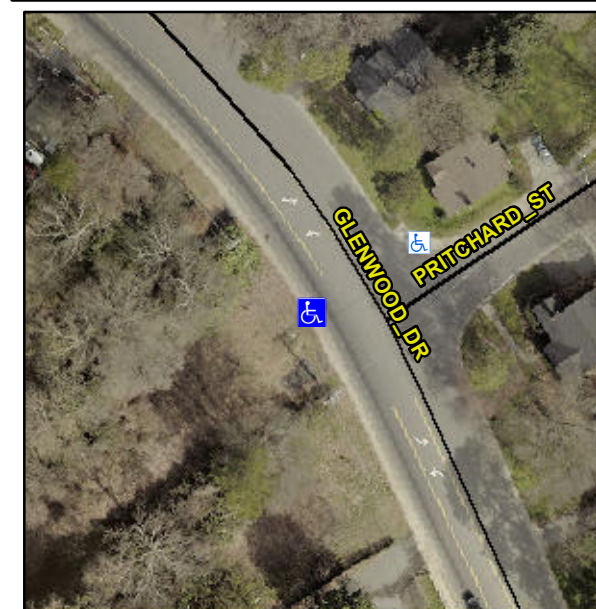
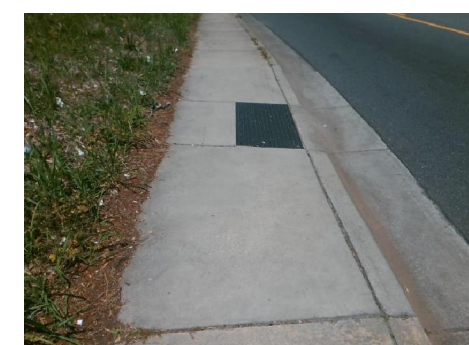
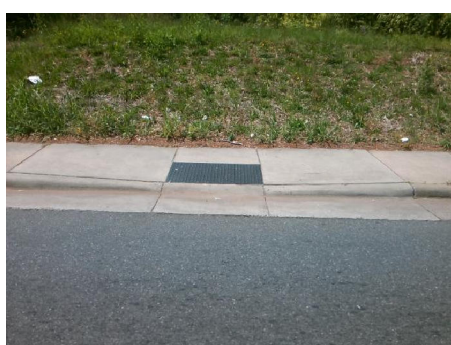
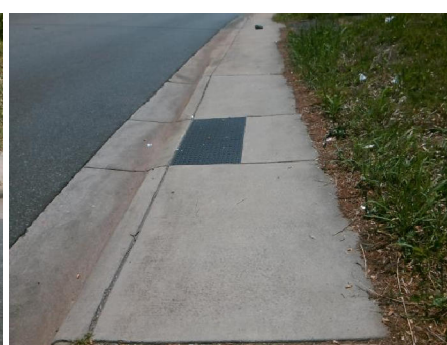
| ADA ID: D64AF72F869C | Ramp Type: Perp | Initial Pass/Fail: Fail | Overall Compliance: No |

**Not Found, R304.5.1, R304.2.2, R304.5.3**

| Compliance | Description | Data | Compliance | Description | Data |
|---|---|---|---|---|---|
| N/A | Ramp Length (in) | 62.0 | No | Ramp Slope (%) | 9.4 |
| No | Ramp Width (in) | 47.5 | No | Ramp XSlope (%) | 5.1 |

**Remove & Replace Entire Ramp.**
