Access Compliance Report

Public Rights-of-Way

(Curb Ramps)

Intersection ID: 6111	Main Street: CHIMNEY_ROCK_CT	Cross Street: WINGSTONE_LN	Location: NE
ADA ID: D65264573436	Ramp Type: Perp	Initial Pass/Fail: Fail	Overall Compliance: No
Codes/Mitigation Info/Possible Solution			Severity Score: 10
			Field Measurements/Component Compliance

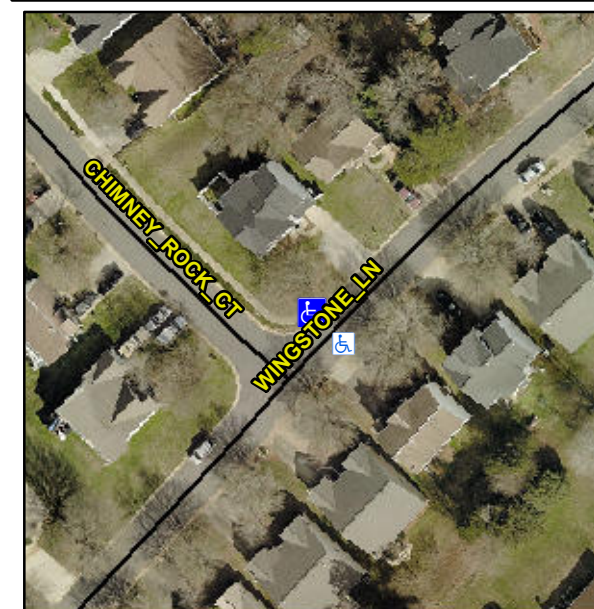
Not Found, R304.5.1

Compliance	Description	Data	Compliance	Description	Data
N/A	Ramp Length (in)	48.0	Yes	Ramp Slope (%)	6.9
No	Ramp Width (in)	47.5	Yes	Ramp XSlope (%)	2.6
N/A	Flare Type LT	N/A	N/A	Flare Type RT	N/A
N/A	Flare Slope LT (%)	N/A	N/A	Flare Slope RT (%)	N/A
N/A	Flare Traversable LT?	N/A	N/A	Flare Traversable RT?	N/A
N/A	Landing Length (in)	N/A	N/A	DWS Provided?	N/A
N/A	Landing Width (in)	N/A	N/A	DWS Contrast?	N/A
N/A	Landing Slope (%)	N/A	N/A	DWS Length (in)	N/A
N/A	Landing X Slope (%)	N/A	N/A	DWS Full Width?	N/A
N/A	Landing Curb? (Y/N)	N/A	N/A	DWS Offset (in)	N/A
N/A	Shared Landing?	N/A			
N/A	Gutter Ponding?	N/A	N/A	Gutter Slope (%)	N/A
N/A	Gutter Lip Ht (in)	N/A	N/A	Gutter X Slope (%)	N/A
N/A	Painted X Walk1?	No	N/A	Painted X Walk2?	N/A
	X Walk 1 Direction	To S		X Walk 2 Direction	N/A
N/A	X Walk 1 Width (in)	N/A	N/A	X Walk 2 Width (in)	N/A
	X Walk 1 Slope (%)	0.4		X Walk 2 Slope (%)	N/A
	X Walk 1 X Slope (%)	3.2		X Walk 2 X Slope (%)	N/A

N/A	Ramp inside XWalk1?	N/A	N/A	Ramp inside XWalk2?	N/A
	Road Slope (%)	N/A	N/A	Clear Space?	N/A
	Road X Slope (%)	N/A	N/A	Clear Space to XWalk (in)	N/A
N/A	Any Obstructions?	N/A	N/A	Storm Grate/Utility Hazard?	N/A
	Obstruction Type			Storm Grate/Utility Type	
		N/A			N/A
			Yes	Surface Condition? (G/P)	Good

Possible Solutions:

Remove & Replace Entire Ramp.

Total Cost: \$ 1850.00
