# Access Compliance Report

## Public Rights-of-Way

### (Curb Ramps)

Intersection ID: 4775	Main Street: OLD_STATESVILLE_RD	Cross Street: HENDERSON_CR	Location: W
ADA ID: D656074770A5	Ramp Type: Perp	Initial Pass/Fail: Fail	Overall Compliance: No
Severity Score: 21.25			
Codes/Mitigation Info/Possible Solution		Field Measurements/Component Compliance

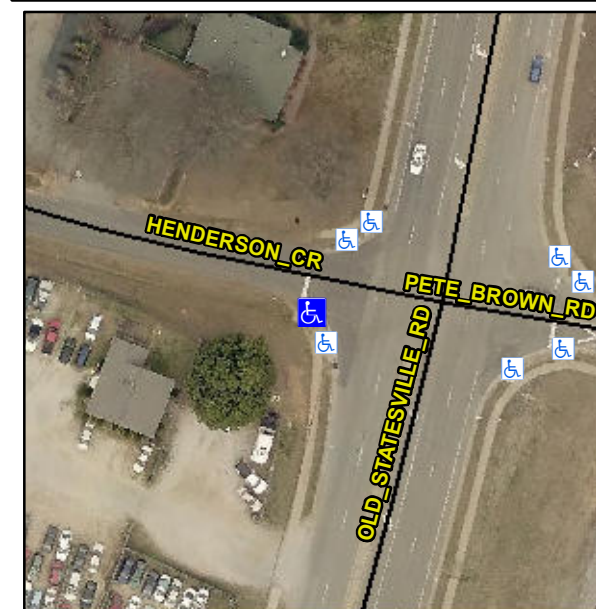
**Not Found, R304.5.1, R304.2.2**

Compliance	Description	Data	Compliance	Description	Data
N/A	Ramp Length (in)	60.0	No	Ramp Slope (%)	11.5
No	Ramp Width (in)	41.0	Yes	Ramp XSlope (%)	0.8
N/A	Flare Type LT	N/A	N/A	Flare Type RT	N/A
N/A	Flare Slope LT (%)	N/A	N/A	Flare Slope RT (%)	N/A
N/A	Flare Traversable LT?	N/A	N/A	Flare Traversable RT?	N/A
N/A	Landing Length (in)	N/A	N/A	DWS Provided?	N/A
N/A	Landing Width (in)	N/A	N/A	DWS Contrast?	N/A
N/A	Landing Slope (%)	N/A	N/A	DWS Length (in)	N/A
N/A	Landing X Slope (%)	N/A	N/A	DWS Full Width?	N/A
N/A	Landing Curb? (Y/N)	N/A	N/A	DWS Offset (in)	N/A
N/A	Shared Landing?	N/A			
N/A	Gutter Ponding?	N/A	N/A	Gutter Slope (%)	N/A
N/A	Gutter Lip Ht (in)	N/A	N/A	Gutter X Slope (%)	N/A
N/A	Painted X Walk1?	No	N/A	Painted X Walk2?	N/A
	X Walk 1 Direction	To N		X Walk 2 Direction	N/A
N/A	X Walk 1 Width (in)	N/A	N/A	X Walk 2 Width (in)	N/A
	X Walk 1 Slope (%)	0.8		X Walk 2 Slope (%)	N/A
	X Walk 1 X Slope (%)	2.0		X Walk 2 X Slope (%)	N/A

N/A	Ramp inside XWalk1?	N/A	N/A	Ramp inside XWalk2?	N/A
	Road Slope (%)	N/A	N/A	Clear Space?	N/A
	Road X Slope (%)	N/A	N/A	Clear Space to XWalk (in)	N/A
N/A	Any Obstructions?	N/A	N/A	Storm Grate/Utility Hazard?	N/A
	Obstruction Type			Storm Grate/Utility Type	
		N/A			N/A
			Yes	Surface Condition? (G/P)	Good

**Remove & Replace Entire Ramp.**
