# Access Compliance Report

## Public Rights-of-Way

### (Curb Ramps)

| Intersection ID: 20510 | Main Street: FAIRVIEW_RD | Cross Street: ARBOR_WAY | Location: NW |

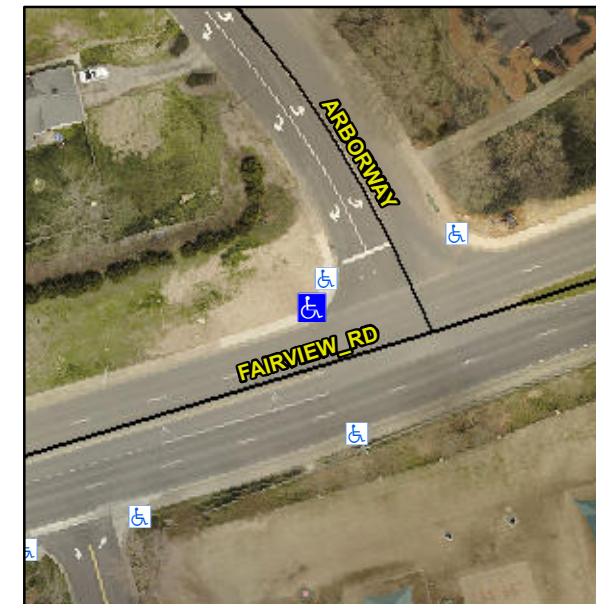
| ADA ID: D65E10C7FFF1 | Ramp Type: Perp | Initial Pass/Fail: Fail | Overall Compliance: No |
| Severity Score: 13.75 | | | |

**Not Found, R304.2.2**

| Compliance | Description | Data | Compliance | Description | Data |
|---|---|---|---|---|---|
| N/A | Ramp Length (in) | 53.0 | No | Ramp Slope (%) | 8.5 |

**Remove & Replace Entire Ramp.**

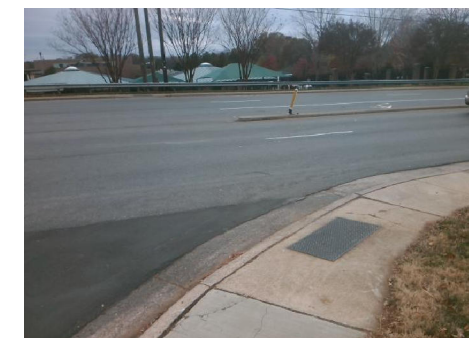
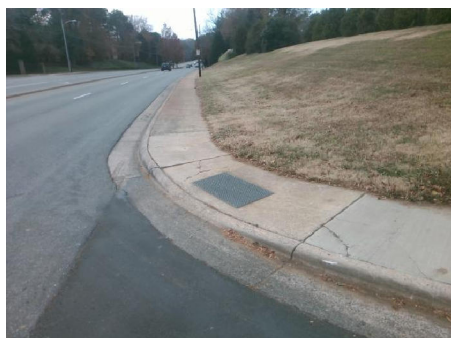
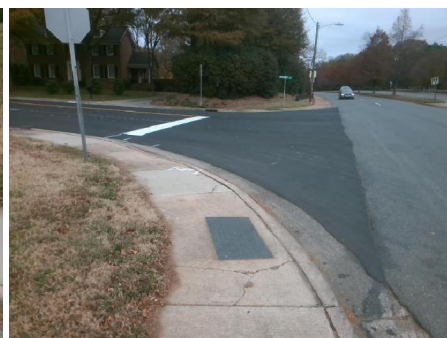
| Compliance | Description | Data | Compliance | Description | Data |
|---|---|---|---|---|---|
| Yes | Ramp Width (in) | 48.0 | Yes | Ramp XSlope (%) | 4.5 |
| | | | Yes | Surface Condition? (G/P) | Good |
