Access Compliance Report

Public Rights-of-Way

(Curb Ramps)

Intersection ID: 19795	Main Street: EMERYWOOD_DR	Cross Street: NETHERWOOD_DR	Location:	W
ADA ID: D660C12D6D6F	Ramp Type: BlendTrans2	Initial Pass/Fail: Fail	Overall Compliance: No	Severity Score: 12.5

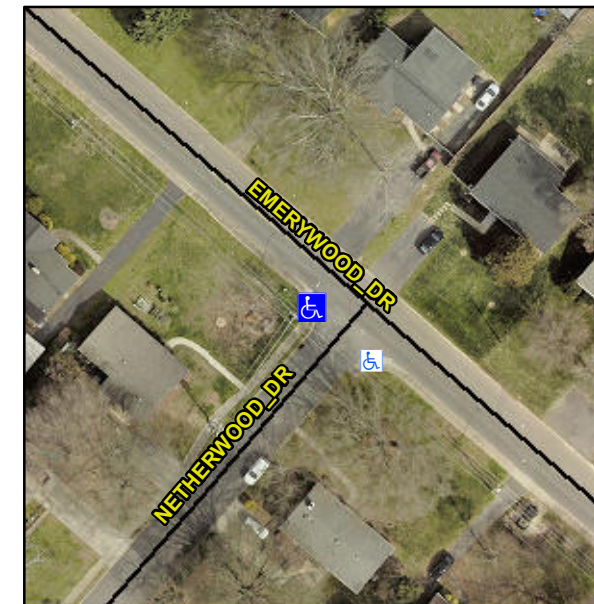
Not Found, R304.5.3

Compliance	Description	Data	Compliance	Description	Data
N/A	Ramp Length (in)	81.0	Yes	BlendTrans Slope (%)	4.0
Yes	Ramp Width (in)	48.0	No	BlendTrans XSlope (%)	5.1
N/A	Flare Type LT	N/A	N/A	Flare Type RT	N/A
N/A	Flare Slope LT (%)	N/A	N/A	Flare Slope RT (%)	N/A
N/A	Flare Traversable LT?	N/A	N/A	Flare Traversable RT?	N/A
N/A	Landing Length (in)	N/A	N/A	DWS Provided?	N/A
N/A	Landing Width (in)	N/A	N/A	DWS Contrast?	N/A
N/A	Landing Slope (%)	N/A	N/A	DWS Length (in)	N/A
N/A	Landing X Slope (%)	N/A	N/A	DWS Full Width?	N/A
N/A	Landing Curb? (Y/N)	N/A	N/A	DWS Offset (in)	N/A
N/A	Shared Landing?	N/A			
N/A	Gutter Ponding?	N/A	N/A	Gutter Slope (%)	N/A
N/A	Gutter Lip Ht (in)	N/A	N/A	Gutter X Slope (%)	N/A
N/A	Painted X Walk1?	No	N/A	Painted X Walk2?	No
	X Walk 1 Direction	To SE		X Walk 2 Direction	To NE
	X Walk 1 Width (in)	N/A		X Walk 2 Width (in)	N/A
	X Walk 1 Slope (%)	0.6		X Walk 2 Slope (%)	6.3
	X Walk 1 X Slope (%)	1.5		X Walk 2 X Slope (%)	1.1

N/A	Ramp inside XWalk1?	N/A	N/A	Ramp inside XWalk2?	N/A
	Road Slope (%)	2.7		Clear Space?	N/A
	Road X Slope (%)	8.7	N/A	Clear Space to XWalk (in)	N/A
N/A	Any Obstructions?	N/A	N/A	Storm Grate/Utility Hazard?	N/A
	Obstruction Type			Storm Grate/Utility Type	
		N/A			N/A
			Yes	Surface Condition? (G/P)	Good
			No	Curb Slope (%)	17.3

Remove & Replace Curb Ramp With Two New Directional Ramps or Equivalent.

Total Cost: \$ 3200.00

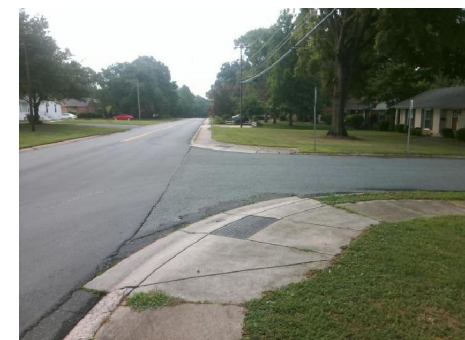
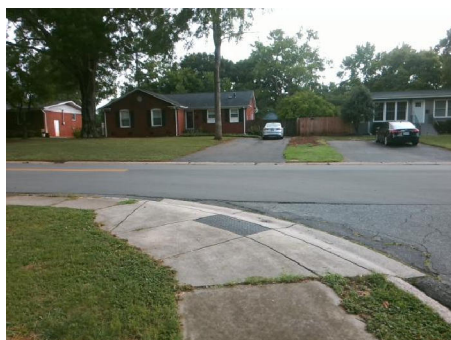
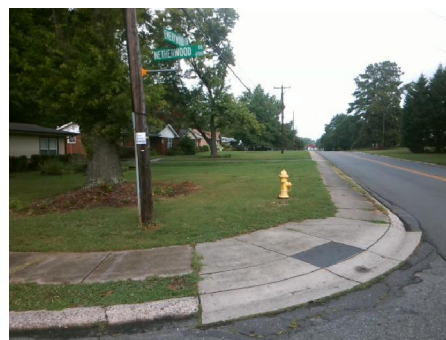
Street 1 Name **NETHERWOOD DR**
 Stop Condition-Street 1 **StopSign**
 Street 2 Name **EMERYWOOD DR**
 Stop Condition-Street 2 **None**
