Access Compliance Report

Public Rights-of-Way

(Curb Ramps)

Intersection ID: N/A	Main Street: CRESSWIND BV	Cross Street: FESTIVAL WY	Location: SE
ADA ID: D66666E698A4	Ramp Type: Perp	Initial Pass/Fail: Fail	Overall Compliance: No
Severity Score: 1.25			
Codes/Mitigation Info/Possible Solution		Field Measurements/Component Compliance

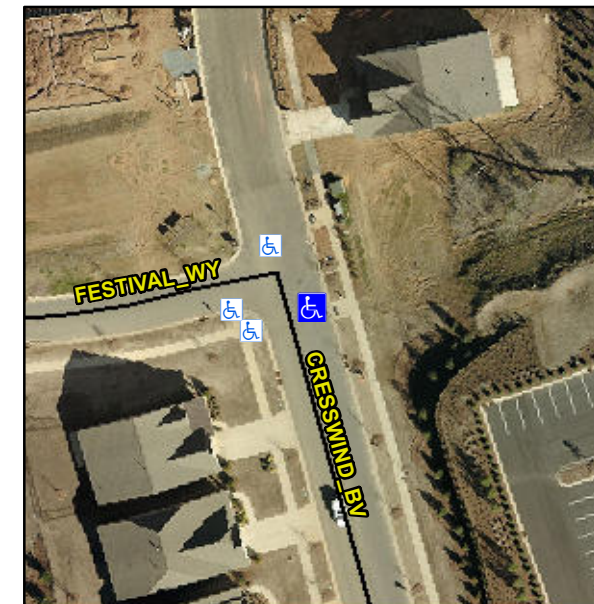
Compliance	Description	Data	Compliance	Description	Data
N/A	Ramp Length (in)	98.0	Yes	Ramp Slope (%)	5.2
Yes	Ramp Width (in)	56.0	No	Ramp XSlope (%)	4.9
N/A	Flare Type LT	N/A	N/A	Flare Type RT	N/A
N/A	Flare Slope LT (%)	N/A	N/A	Flare Slope RT (%)	N/A
N/A	Flare Traversable LT?	No	N/A	Flare Traversable RT?	No
N/A	Landing Length (in)	N/A	N/A	DWS Provided?	N/A
N/A	Landing Width (in)	N/A	N/A	DWS Contrast?	N/A
N/A	Landing Slope (%)	N/A	N/A	DWS Length (in)	N/A
N/A	Landing X Slope (%)	N/A	N/A	DWS Full Width?	N/A
N/A	Landing Curb? (Y/N)	N/A	N/A	DWS Offset (in)	N/A
N/A	Shared Landing?	N/A			
N/A	Gutter Ponding?	N/A	N/A	Gutter Slope (%)	N/A
N/A	Gutter Lip Ht (in)	N/A	N/A	Gutter X Slope (%)	N/A
N/A	Painted X Walk1?	No	N/A	Painted X Walk2?	N/A
	X Walk 1 Direction	To W		X Walk 2 Direction	N/A
N/A	X Walk 1 Width (in)	N/A	N/A	X Walk 2 Width (in)	N/A
	X Walk 1 Slope (%)	3.7		X Walk 2 Slope (%)	N/A
	X Walk 1 X Slope (%)	3.3		X Walk 2 X Slope (%)	N/A

N/A	Ramp inside XWalk1?	N/A	N/A	Ramp inside XWalk2?	N/A
	Road Slope (%)	N/A	N/A	Clear Space?	N/A
	Road X Slope (%)	N/A	N/A	Clear Space to XWalk (in)	N/A
N/A	Any Obstructions?	N/A	N/A	Storm Grate/Utility Hazard?	N/A
	Obstruction Type			Storm Grate/Utility Type	
		N/A			N/A
		Yes		Surface Condition? (G/P)	Good

Possible Solutions:

Remove & Replace Entire Ramp.

R304.5.3
