Access Compliance Report

Public Rights-of-Way

(Curb Ramps)

Intersection ID: 13422	Main Street: E_W_T_HARRIS_BV	Cross Street: TRYSTING_RD	Location: SE
ADA ID: D6687EB6D29B	Ramp Type: PerpDiag	Initial Pass/Fail: Fail	Overall Compliance: No
Severity Score: 22.5			
Codes/Mitigation Info/Possible Solution		Field Measurements/Component Compliance

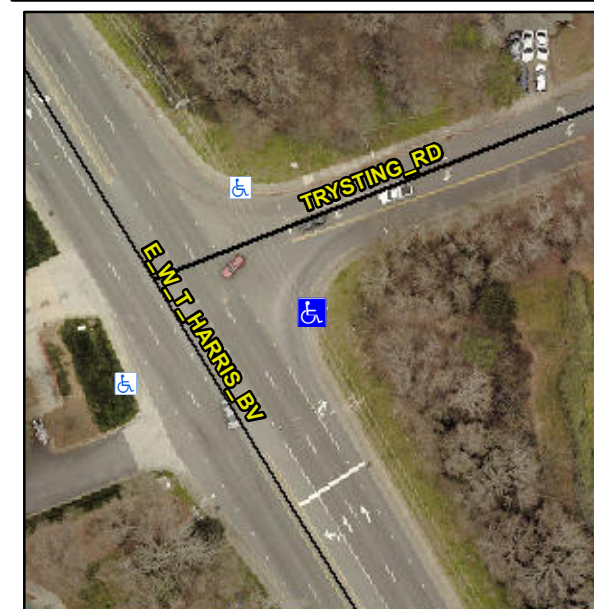
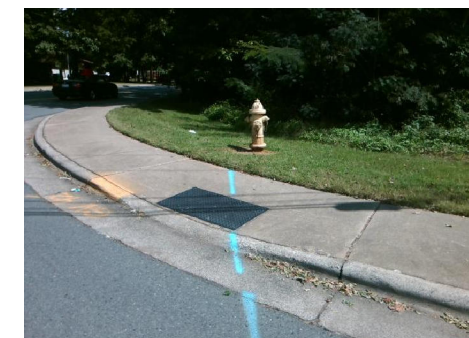
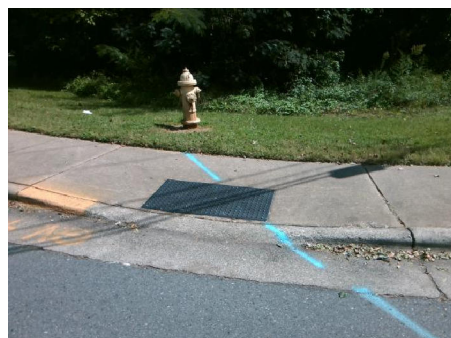
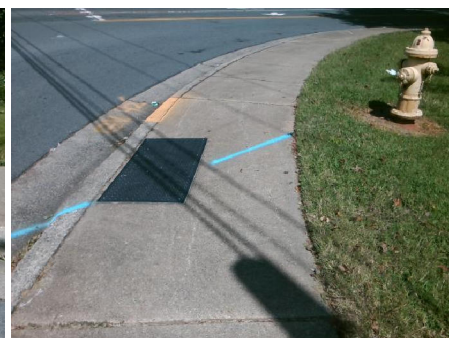
Not Found, R304.5.1, R304.2.2, R304.5.3

Compliance	Description	Data	Compliance	Description	Data
N/A	Ramp Length (in)	61.0	No	Ramp Slope (%)	8.9
No	Ramp Width (in)	47.0	No	Ramp XSlope (%)	2.4
N/A	Flare Type LT	N/A	N/A	Flare Type RT	N/A
N/A	Flare Slope LT (%)	N/A	N/A	Flare Slope RT (%)	N/A
N/A	Flare Traversable LT?	N/A	N/A	Flare Traversable RT?	N/A
N/A	Landing Length (in)	N/A	N/A	DWS Provided?	N/A
N/A	Landing Width (in)	N/A	N/A	DWS Contrast?	N/A
N/A	Landing Slope (%)	N/A	N/A	DWS Length (in)	N/A
N/A	Landing X Slope (%)	N/A	N/A	DWS Full Width?	N/A
N/A	Landing Curb? (Y/N)	N/A	N/A	DWS Offset (in)	N/A
N/A	Shared Landing?	N/A			
N/A	Gutter Ponding?	N/A	N/A	Gutter Slope (%)	N/A
N/A	Gutter Lip Ht (in)	N/A	N/A	Gutter X Slope (%)	N/A
N/A	Painted X Walk1?	No	N/A	Painted X Walk2?	No
	X Walk 1 Direction	To N		X Walk 2 Direction	To W
N/A	X Walk 1 Width (in)	N/A	N/A	X Walk 2 Width (in)	N/A
	X Walk 1 Slope (%)	0.2		X Walk 2 Slope (%)	2.9
	X Walk 1 X Slope (%)	1.9		X Walk 2 X Slope (%)	0.3

N/A	Ramp inside XWalk1?	N/A	N/A	Ramp inside XWalk2?	N/A
	Road Slope (%)	1.3	N/A	Clear Space?	N/A
	Road X Slope (%)	0.4	N/A	Clear Space to XWalk (in)	N/A
N/A	Any Obstructions?	N/A	N/A	Storm Grate/Utility Hazard?	N/A
	Obstruction Type			Storm Grate/Utility Type	
		N/A			N/A
			Yes	Surface Condition? (G/P)	Good

Possible Solutions:

Remove & Replace Curb Ramp With Two New Directional Ramps or Equivalent.
