Access Compliance Report

Public Rights-of-Way

(Curb Ramps)

Intersection ID: 14741	Main Street: EAST_BV	Cross Street: PARK_RD	Location: SW
ADA ID: D66ACBD825EC	Ramp Type: Directional1	Initial Pass/Fail: Fail	Overall Compliance: No
Severity Score: 13.75			
Codes/Mitigation Info/Possible Solution		Field Measurements/Component Compliance

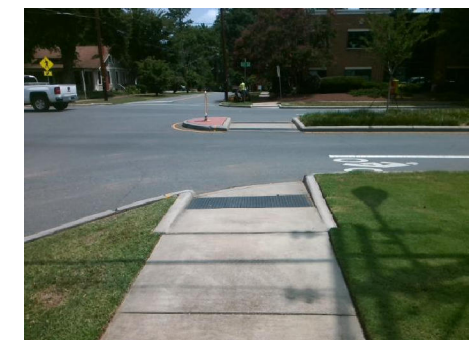
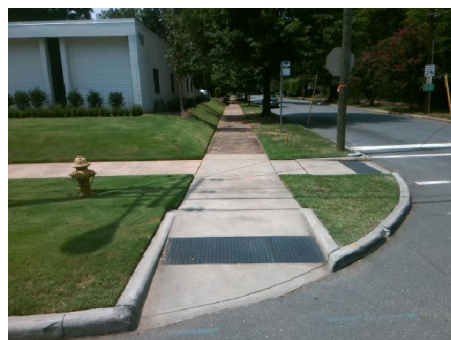
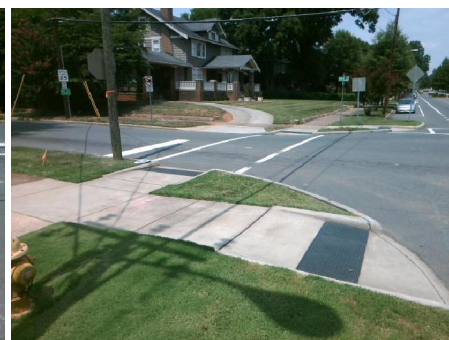
Compliance	Description	Data	Compliance	Description	Data
N/A	Ramp Length (in)	59.0	N/A	Grade Break?	N/A
Yes	Ramp Width (in)	72.0	N/A	Grade Break Slope (%)	0.0
No	Ramp Slope (%)	8.8	N/A	Grade Break XSlope (%)	0.0
No	Ramp XSlope (%)	2.1			
N/A	Flare Type LT	N/A	N/A	Flare Type RT	N/A
N/A	Flare Slope LT (%)	N/A	N/A	Flare Slope RT (%)	0.0
N/A	Flare Traversable LT?	N/A	N/A	Flare Traversable RT?	N/A
N/A	Landing Length (in)	0.0	N/A	DWS Provided?	N/A
N/A	Landing Width (in)	0.0	N/A	DWS Contrast?	N/A
N/A	Landing Slope (%)	0.0	N/A	DWS Length (in)	N/A
N/A	Landing X Slope (%)	0.0	N/A	DWS Full Width?	N/A
N/A	Landing Curb? (Y/N)	N/A	N/A	DWS Offset LT (in)	N/A
N/A	Shared Landing?	N/A	N/A	DWS Offset RT (in)	N/A
N/A	Gutter Ponding?	0.0	N/A	Gutter Slope (%)	N/A
N/A	Gutter Lip Ht (in)	0.0	N/A	Gutter X Slope (%)	N/A
N/A	Painted X Walk1?	No		Road Slope (%)	3.6
	X Walk 1 Direction	To NE		Road X Slope (%)	0.5
	X Walk 1 Width (in)	N/A		Clear Space?	N/A

X Walk 1 Slope (%)	3.6	N/A	Clear Space to XWalk (in)	N/A
	X Walk 1 X Slope (%)	0.5	N/A	Storm Grate/Utility Hazard?	N/A
N/A	Ramp inside XWalk1?	N/A		Storm Grate/Utility Type	
N/A	Any Obstructions?	N/A			N/A
	Obstruction Type		Yes	Surface Condition? (G/P)	Good
			N/A	Curb Slope (%)	7.4

Remove & Replace Entire Ramp.
