Access Compliance Report

Public Rights-of-Way

(Curb Ramps)

Intersection ID: N/A	Main Street: LEDERER_AV	Cross Street: LIBERTY_HALL_CT	Location: SE
ADA ID: D66AE2306647	Ramp Type: Perp	Initial Pass/Fail: Fail	Overall Compliance: No
		Severity Score: 12.5

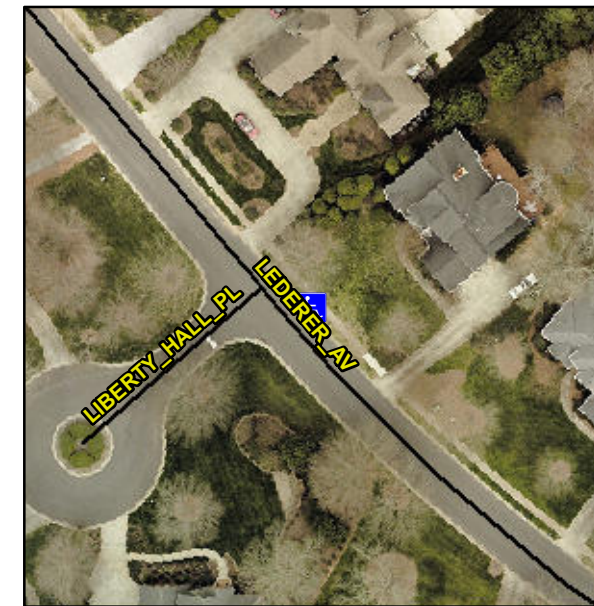
Compliance	Description	Data	Compliance	Description	Data
N/A	Ramp Length (in)	48.0	No	Ramp Slope (%)	11.5
Yes	Ramp Width (in)	48.0	Yes	Ramp XSlope (%)	1.5
N/A	Flare Type LT	N/A	N/A	Flare Type RT	N/A
N/A	Flare Slope LT (%)	N/A	N/A	Flare Slope RT (%)	N/A
N/A	Flare Traversable LT?	N/A	N/A	Flare Traversable RT?	N/A
N/A	Landing Length (in)	N/A	N/A	DWS Provided?	N/A
N/A	Landing Width (in)	N/A	N/A	DWS Contrast?	N/A
N/A	Landing Slope (%)	N/A	N/A	DWS Length (in)	N/A
N/A	Landing X Slope (%)	N/A	N/A	DWS Full Width?	N/A
N/A	Landing Curb? (Y/N)	N/A	N/A	DWS Offset (in)	N/A
N/A	Shared Landing?	N/A			
N/A	Gutter Ponding?	N/A	N/A	Gutter Slope (%)	N/A
N/A	Gutter Lip Ht (in)	N/A	N/A	Gutter X Slope (%)	N/A
N/A	Painted X Walk1?	No	N/A	Painted X Walk2?	N/A
	X Walk 1 Direction	To SW		X Walk 2 Direction	N/A
N/A	X Walk 1 Width (in)	N/A	N/A	X Walk 2 Width (in)	N/A
	X Walk 1 Slope (%)	2.9		X Walk 2 Slope (%)	N/A
	X Walk 1 X Slope (%)	0.2		X Walk 2 X Slope (%)	N/A

Remove & Replace Entire Ramp.

Not Found, R304.2.2
