# Access Compliance Report

## Public Rights-of-Way

### (Curb Ramps)

| ADA ID: D67877BC70C1 | Ramp Type: PerpDiag | Initial Pass/Fail: Fail | Overall Compliance: No |

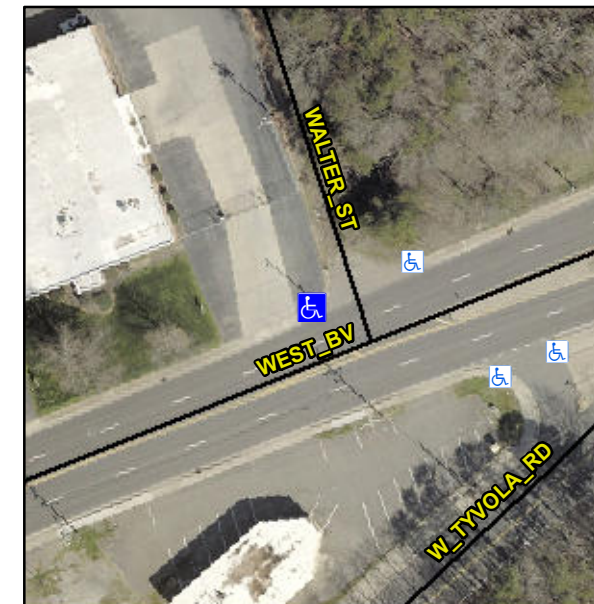
**Not Found, R304.5.1, R304.2.2**

| Compliance | Description | Data | Compliance | Description | Data |
|---|---|---|---|---|---|
| N/A | Ramp Length (in) | 49.0 | No | Ramp Slope (%) | 9.0 |
| No | Ramp Width (in) | 45.5 | Yes | Ramp XSlope (%) | 1.0 |

**Remove & Replace Curb Ramp With Two New Directional Ramps or Equivalent.**
