Access Compliance Report

Public Rights-of-Way

(Curb Ramps)

Intersection ID: 11368	Main Street: ERSKINE_DR	Cross Street: SHAMROCK_DR	Location: NW
ADA ID: D67988061A44	Ramp Type: Perp	Initial Pass/Fail: Fail	Overall Compliance: No
		Severity Score: 22.5

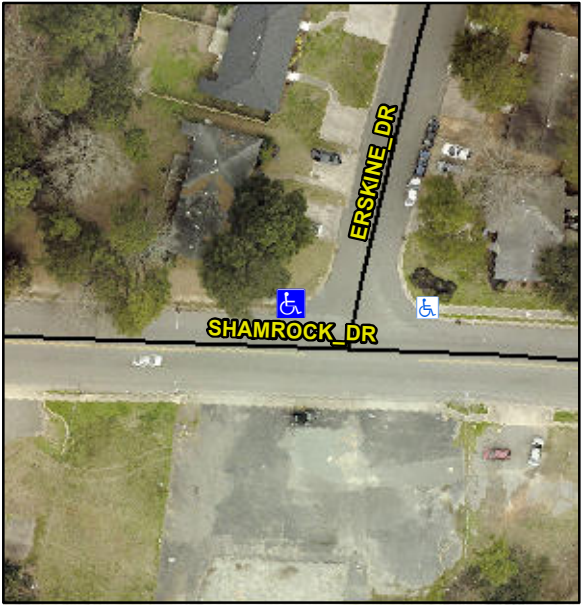
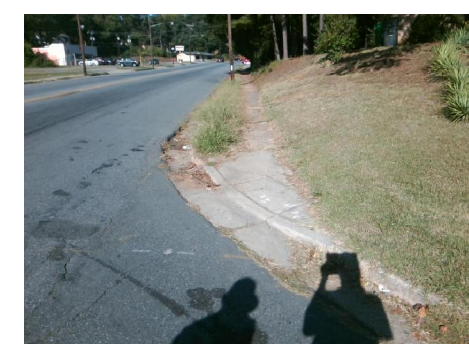
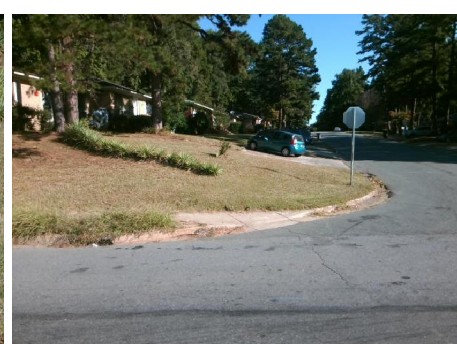
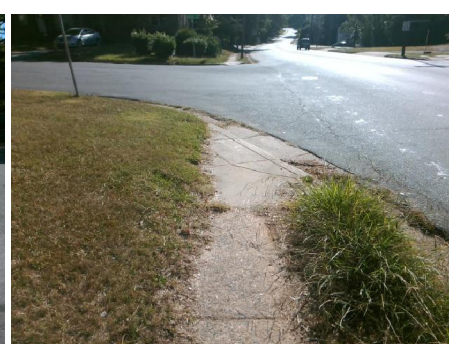
Possible Solutions:		Compliance	Description	Data
	Remove & Replace Entire Ramp.		No	Ramp Length (in)	26.0
			No	Ramp Width (in)	46.0
			N/A	Flare Type LT	N/A
			N/A	Flare Slope LT (%)	N/A
			N/A	Flare Traversable LT?	N/A
			N/A	Landing Length (in)	N/A
			N/A	Landing Width (in)	N/A
			N/A	Landing Slope (%)	N/A
			N/A	Landing X Slope (%)	N/A
<p>Surveyor Notes:</p> <p>N/A</p> <p>PROW/ADA:</p> <p>Not Found, R304.5.1, R304.2.2, R304.5.3</p>			N/A	Flare Type RT	N/A
			N/A	Flare Slope RT (%)	N/A
			N/A	Flare Traversable RT?	N/A
			N/A	DWS Provided?	N/A
			N/A	DWS Contrast?	N/A
			N/A	DWS Length (in)	N/A
			N/A	DWS Full Width?	N/A
			N/A	DWS Offset (in)	N/A
			N/A	Gutter Slope (%)	N/A
			N/A	Gutter X Slope (%)	N/A
<p>Total Cost:</p> <p>\$ 1850.00</p>			No	Painted X Walk2?	N/A
			To E	X Walk 2 Direction	N/A
			N/A	X Walk 2 Width (in)	N/A

0.6	X Walk 2 Slope (%)	N/A
			3.5	X Walk 2 X Slope (%)	N/A
			N/A	Ramp inside XWalk2?	N/A
			N/A	Clear Space?	N/A
			N/A	Clear Space to XWalk (in)	N/A
			N/A	Storm Grate/Utility Hazard?	N/A
			N/A	Storm Grate/Utility Type	N/A
			N/A	Surface Condition? (G/P)	Good
