Access Compliance Report

Public Rights-of-Way

(Curb Ramps)

Intersection ID: 13738	Main Street: VIOLA_DR	Cross Street: PENCE_RD	Location: S
ADA ID: D685997EF9C8	Ramp Type: Perp	Initial Pass/Fail: Fail	Overall Compliance: No
		Severity Score: 17.5

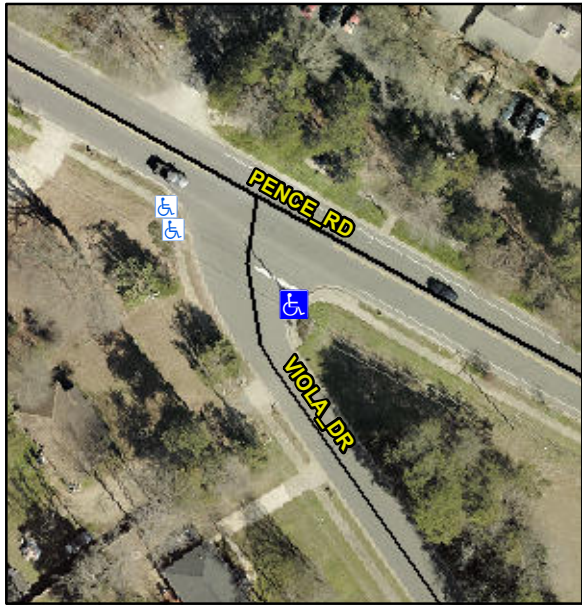
Possible Solutions:		Compliance	Description	Data	Compliance	Description	Data
	Remove & Replace Entire Ramp.		N/A	Ramp Length (in)	60.0	Yes	Ramp Slope (%)	7.7
			No	Ramp Width (in)	34.5	Yes	Ramp XSlope (%)	1.6
			N/A	Flare Type LT	N/A	N/A	Flare Type RT	N/A
			N/A	Flare Slope LT (%)	N/A	N/A	Flare Slope RT (%)	N/A
			N/A	Flare Traversable LT?	N/A	N/A	Flare Traversable RT?	N/A
			N/A	Landing Length (in)	N/A	N/A	DWS Provided?	N/A
			N/A	Landing Width (in)	N/A	N/A	DWS Contrast?	N/A
			N/A	Landing Slope (%)	N/A	N/A	DWS Length (in)	N/A
			N/A	Landing X Slope (%)	N/A	N/A	DWS Full Width?	N/A
Surveyor Notes:	N/A		N/A	Landing Curb? (Y/N)	N/A	N/A	DWS Offset (in)	N/A
			N/A	Shared Landing?	N/A			
	PROW/ADA:		N/A	Gutter Ponding?	N/A	N/A	Gutter Slope (%)	N/A
	Not Found, R304.5.1		N/A	Gutter Lip Ht (in)	0.5	N/A	Gutter X Slope (%)	N/A

N/A	Painted X Walk1?	No	N/A	Painted X Walk2?	N/A
				X Walk 1 Direction	To NW		X Walk 2 Direction	N/A
			N/A	X Walk 1 Width (in)	N/A	N/A	X Walk 2 Width (in)	N/A
				X Walk 1 Slope (%)	3.4		X Walk 2 Slope (%)	N/A
				X Walk 1 X Slope (%)	1.8		X Walk 2 X Slope (%)	N/A
			N/A	Ramp inside XWalk1?	N/A	N/A	Ramp inside XWalk2?	N/A
			Road Slope (%)	N/A	N/A	Clear Space?	N/A	
			Road X Slope (%)	N/A	N/A	Clear Space to XWalk (in)	N/A	
		N/A	Any Obstructions?	N/A	N/A	Storm Grate/Utility Hazard?	N/A	
			Obstruction Type			Storm Grate/Utility Type		
					N/A		N/A	
						Yes	Surface Condition? (G/P)	Good
Total Cost:		\$ 1850.00
