# Access Compliance Report

## Public Rights-of-Way

### (Curb Ramps)

Intersection ID: N/A	Main Street: PAMPLIN_CT	Cross Street: PAISLEY_ABBEY_LN	Location: NE
ADA ID: D6880D3BD2A7	Ramp Type: Perp	Initial Pass/Fail: Fail	Overall Compliance: No
		Severity Score: 12.5

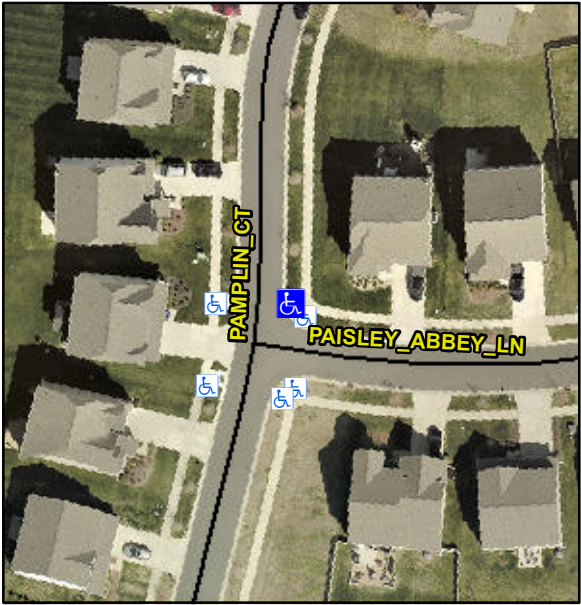
Compliance	Description	Data	Compliance	Description	Data
N/A	Ramp Length (in)	98.5	Yes	Ramp Slope (%)	7.2
Yes	Ramp Width (in)	48.0	No	Ramp XSlope (%)	5.8
N/A	Flare Type LT	N/A	N/A	Flare Type RT	N/A
N/A	Flare Slope LT (%)	N/A	N/A	Flare Slope RT (%)	N/A
N/A	Flare Traversable LT?	N/A	N/A	Flare Traversable RT?	N/A
N/A	Landing Length (in)	N/A	N/A	DWS Provided?	N/A
N/A	Landing Width (in)	N/A	N/A	DWS Contrast?	N/A
N/A	Landing Slope (%)	N/A	N/A	DWS Length (in)	N/A
N/A	Landing X Slope (%)	N/A	N/A	DWS Full Width?	N/A
N/A	Landing Curb? (Y/N)	N/A	N/A	DWS Offset (in)	N/A
N/A	Shared Landing?	N/A			
N/A	Gutter Ponding?	N/A	N/A	Gutter Slope (%)	N/A
N/A	Gutter Lip Ht (in)	N/A	N/A	Gutter X Slope (%)	N/A
N/A	Painted X Walk1?	No	N/A	Painted X Walk2?	N/A
	X Walk 1 Direction	To NW		X Walk 2 Direction	N/A
N/A	X Walk 1 Width (in)	N/A	N/A	X Walk 2 Width (in)	N/A
	X Walk 1 Slope (%)	3.0		X Walk 2 Slope (%)	N/A
	X Walk 1 X Slope (%)	2.7		X Walk 2 X Slope (%)	N/A

N/A	Ramp inside XWalk1?	N/A	N/A	Ramp inside XWalk2?	N/A
	Road Slope (%)	N/A	N/A	Clear Space?	N/A
	Road X Slope (%)	N/A	N/A	Clear Space to XWalk (in)	N/A
N/A	Any Obstructions?	N/A	N/A	Storm Grate/Utility Hazard?	N/A
	Obstruction Type			Storm Grate/Utility Type	
		N/A			N/A
			Yes	Surface Condition? (G/P)	Good

Possible Solutions:				
	Remove & Replace Entire Ramp.				
	Surveyor Notes:				
	N/A				
	PROW/ADA:				
	Not Found, R304.5.3				
Street 1 Name	PAMPLIN CT				
Stop Condition-Street 2	None				
Street 2 Name	N/A				
Stop Condition-Street 1	N/A				
Total Cost:		\$	1850.00
