Access Compliance Report

Public Rights-of-Way

(Curb Ramps)

Intersection ID: 15287	Main Street: ALBEMARLE_RD	Cross Street: N_SHARON_AMITY_RD	Location: SW
ADA ID: D689B285E2B1	Ramp Type: Para	Initial Pass/Fail: Fail	Overall Compliance: No
			Severity Score: 13.75

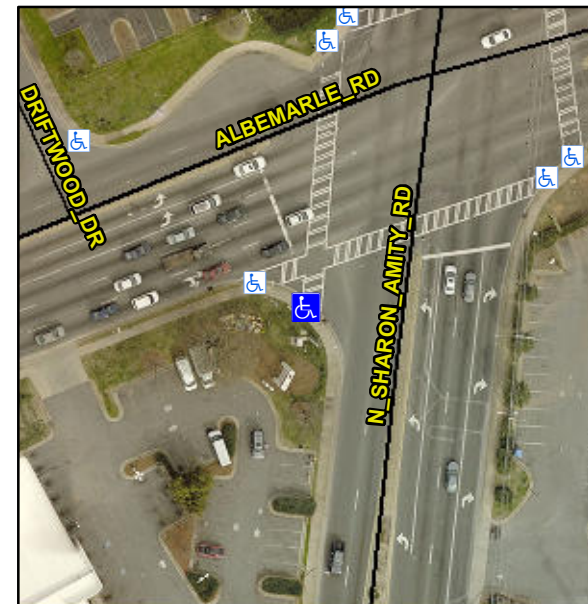
RT RP < 5%

R304.3.2, R304.5.3

Compliance	Description	Data	Compliance	Description	Data
N/A	Ramp Length LT (in)	65.5	N/A	Ramp Length RT (in)	57.5
Yes	Ramp Width LT (in)	65.0	Yes	Ramp Width RT (in)	65.5
No	Ramp Slope LT (%)	10.9	Yes	Ramp Slope RT (%)	1.9
No	Ramp XSlope LT (%)	3.6	No	Ramp XSlope RT (%)	3.9
N/A	Landing Length (in)	N/A	N/A	DWS Provided?	N/A
N/A	Landing Width (in)	N/A	N/A	DWS Contrast?	N/A
N/A	Landing Slope (%)	N/A	N/A	DWS Length (in)	N/A
N/A	Landing X Slope (%)	N/A	N/A	DWS Full Width?	N/A
N/A	Landing Curb? (Y/N)	N/A	N/A	DWS Offset (in)	N/A
N/A	Shared Landing?	N/A			
N/A	Gutter Ponding?	N/A	N/A	Gutter Slope (%)	N/A
N/A	Gutter Lip Ht (in)	N/A	N/A	Gutter X Slope (%)	N/A
N/A	Painted X Walk1?	Yes	N/A	Painted X Walk2?	N/A
	X Walk 1 Direction	To N		X Walk 2 Direction	N/A
N/A	X Walk 1 Width (in)	110.0	N/A	X Walk 2 Width (in)	N/A
	X Walk 1 Slope (%)	4.3		X Walk 2 Slope (%)	N/A
	X Walk 1 X Slope (%)	2.6		X Walk 2 X Slope (%)	N/A
N/A	Ramp inside XWalk1?	Yes	N/A	Ramp inside XWalk2?	N/A

Road Slope (%)	N/A	N/A	Clear Space?	N/A
	Road X Slope (%)	N/A	N/A	Clear Space to XWalk (in)	N/A
N/A	Any Obstructions?	N/A	N/A	Storm Grate/Utility Hazard?	N/A
	Obstruction Type			Storm Grate/Utility Type	
		N/A			N/A
			Yes	Surface Condition? (G/P)	Good
			N/A	Curb Slope (%)	24.6

Remove & Replace Entire Ramp.
