Access Compliance Report Public Rights-of-Way (Curb Ramps)

Intersection ID: 44950 Main Street: WEAVERS GLENN PL **Cross Street: OLDCORN LN** Location: Ε ADA ID: D68A8543E3E7 Ramp Type: PerpDiag Initial Pass/Fail: Fail **Overall Compliance: No Severity Score:** 0

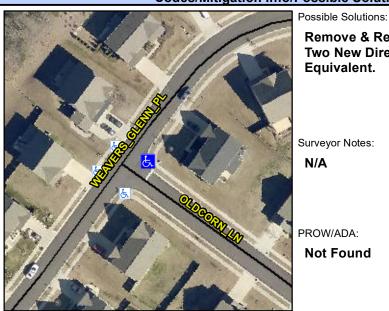
Compl	ance Description	Data	Compl	iance	Description	Data
N/A	Ramp Length (in)	46.0	Yes	Ramp	Slope (%)	5.6
Yes	Ramp Width (in)	48.0	Yes	Ramp	XSlope (%)	1.1
N/A	Flare Type LT	N/A	N/A	Flare	Type RT	N/A
N/A	Flare Slope LT (%)	N/A	N/A	Flare	Slope RT (%)	N/A
N/A	Flare Traversable LT?	N/A	N/A	Flare	Traversable RT?	N/A
N/A	Landing Length (in)	N/A	N/A	DWS	Provided?	N/A
N/A	Landing Width (in)	N/A	N/A	DWS	Contrast?	N/A
N/A	Landing Slope (%)	N/A	N/A	DWS	Length (in)	N/A
N/A	Landing X Slope (%)	N/A	N/A	DWS	Full Width?	N/A
N/A	Landing Curb? (Y/N)	N/A	N/A	DWS	Offset (in)	N/A
N/A	Shared Landing?	N/A				
N/A	Gutter Ponding?	N/A	N/A	Gutte	er Slope (%)	N/A
N/A	Gutter Lip Ht (in)	N/A	N/A	Gutte	er X Slope (%)	N/A
N/A	Painted X Walk1?	No	N/A	Paint	ed X Walk2?	No
	X Walk 1 Direction	To NW		X Wa	lk 2 Direction	To SW
N/A	X Walk 1 Width (in)	N/A	N/A	X Wa	lk 2 Width (in)	N/A
	X Walk 1 Slope (%)	5.7		X Wa	lk 2 Slope (%)	0.2
	X Walk 1 X Slope (%)	1.2		X Wa	lk 2 X Slope (%)	4.2

N/A	Ramp inside XWalk1?	N/A	N/A	Ram	o inside XWalk2?	N/A
	Road Slope (%)	9.8	N/A	Clear	Space?	N/A
	Road X Slope (%)	4.0	N/A	Clear	Space to XWalk (in)	N/A
N/A	Any Obstructions?	N/A	N/A	Storn	n Grate/Utility Hazard?	N/A
	Obstruction Type			Storn	n Grate/Utility Type	
		N/A				N/A

WEAVERS GLENN DR Street 1 Name Stop Condition-Street 2 None Street 2 Name **OLDCORN LN** Stop Condition-Street 1 StopSign **Remove & Replace Curb Ramp With Two New Directional Ramps or** Equivalent.
