Access Compliance Report

Public Rights-of-Way

(Curb Ramps)

Intersection ID: 15522	Main Street: PACES_GLEN_AV	Cross Street: REDDMAN_RD	Location: NW
ADA ID: D693DE06C846	Ramp Type: PerpDiag	Initial Pass/Fail: Fail	Overall Compliance: No
		Severity Score: 35

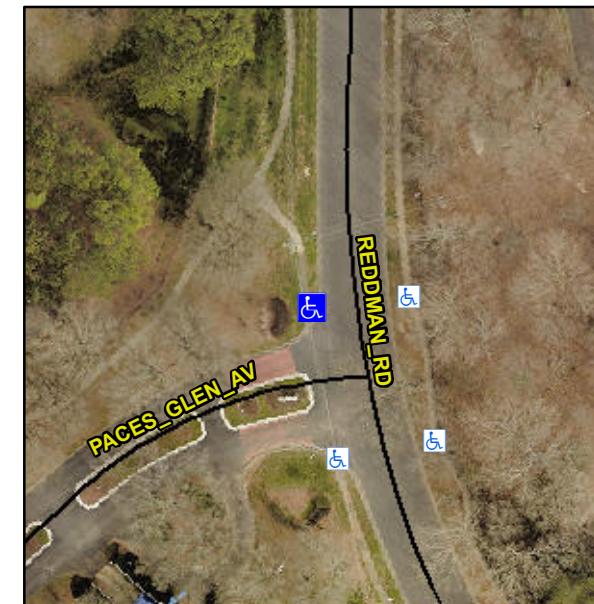
Not Found, R304.5.1, R304.2.2, R304.5.3

Compliance	Description	Data	Compliance	Description	Data
N/A	Ramp Length (in)	52.0	No	Ramp Slope (%)	14.7
No	Ramp Width (in)	46.0	No	Ramp XSlope (%)	3.5
N/A	Flare Type LT	N/A	N/A	Flare Type RT	N/A
N/A	Flare Slope LT (%)	N/A	N/A	Flare Slope RT (%)	N/A
N/A	Flare Traversable LT?	N/A	N/A	Flare Traversable RT?	N/A
N/A	Landing Length (in)	N/A	N/A	DWS Provided?	N/A
N/A	Landing Width (in)	N/A	N/A	DWS Contrast?	N/A
N/A	Landing Slope (%)	N/A	N/A	DWS Length (in)	N/A
N/A	Landing X Slope (%)	N/A	N/A	DWS Full Width?	N/A
N/A	Landing Curb? (Y/N)	N/A	N/A	DWS Offset (in)	N/A
N/A	Shared Landing?	N/A			
N/A	Gutter Ponding?	N/A	N/A	Gutter Slope (%)	N/A
N/A	Gutter Lip Ht (in)	N/A	N/A	Gutter X Slope (%)	N/A
N/A	Painted X Walk1?	No	N/A	Painted X Walk2?	No
	X Walk 1 Direction	To S		X Walk 2 Direction	To E
N/A	X Walk 1 Width (in)	N/A	N/A	X Walk 2 Width (in)	N/A
	X Walk 1 Slope (%)	0.2		X Walk 2 Slope (%)	4.6
	X Walk 1 X Slope (%)	0.3		X Walk 2 X Slope (%)	0.4

N/A	Ramp inside XWalk1?	N/A	N/A	Ramp inside XWalk2?	N/A
	Road Slope (%)	0.9	N/A	Clear Space?	N/A
	Road X Slope (%)	1.2	N/A	Clear Space to XWalk (in)	N/A
N/A	Any Obstructions?	N/A	N/A	Storm Grate/Utility Hazard?	N/A
	Obstruction Type			Storm Grate/Utility Type	
		N/A			N/A
			Yes	Surface Condition? (G/P)	Good

Remove & Replace Curb Ramp With Two New Directional Ramps or Equivalent.
