# Access Compliance Report

## Public Rights-of-Way

### (Curb Ramps)

| Intersection ID: 47226 | Main Street: OAKSHIRE_CR | Cross Street: VALLEYDALE_RD | Location: | N |

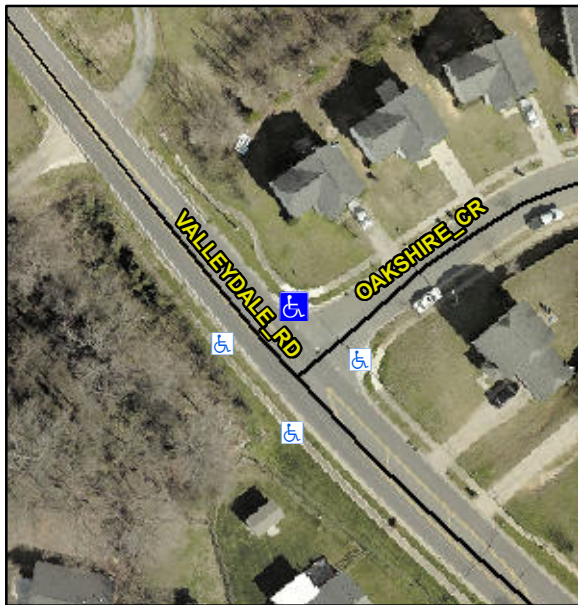
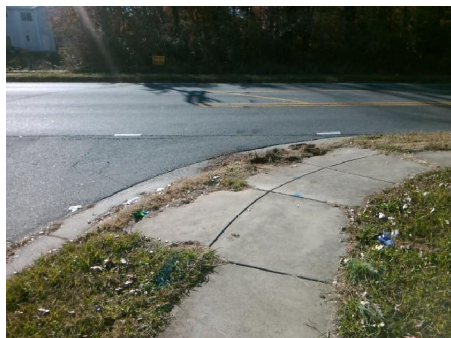
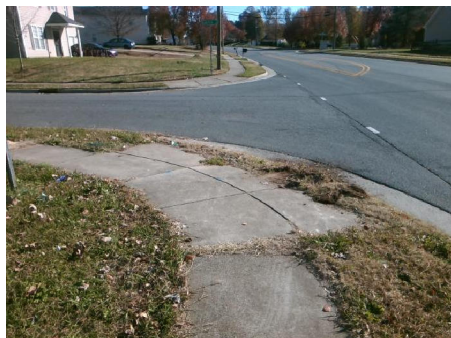
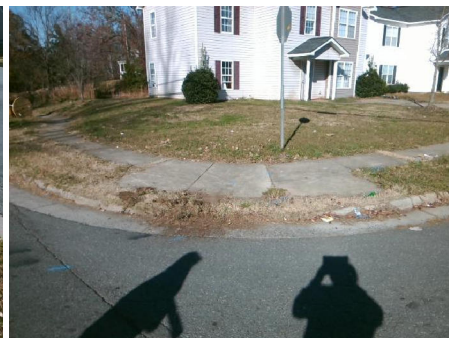
| ADA ID: D6A01B099E0D | Ramp Type: PerpDiag | Initial Pass/Fail: Fail | Overall Compliance: No | Severity Score: 12.5 |

**Not Found, R304.2.2**

| Compliance | Description | Data | Compliance | Description | Data |
|---|---|---|---|---|---|
| N/A | Ramp Length (in) | 48.0 | No | Ramp Slope (%) | 10.3 |
| Yes | Ramp Width (in) | 53.5 | Yes | Ramp XSlope (%) | 1.3 |
| N/A | Gutter Lip Ht (in) | 1.0 | N/A | Gutter X Slope (%) | N/A |

**Remove & Replace Curb Ramp With Two New Directional Ramps or Equivalent.**

Total Cost: \$ 3200.00
