Access Compliance Report

Public Rights-of-Way

(Curb Ramps)

Intersection ID: 48569	Main Street: RED_SQUIRREL_TL	Cross Street: SALAMANDER_RUN_LN	Location: NE
ADA ID: D6A07566B1AD	Ramp Type: Perp	Initial Pass/Fail: Pass	Overall Compliance: No
Severity Score: 0			
Codes/Mitigation Info/Possible Solution		Field Measurements/Component Compliance

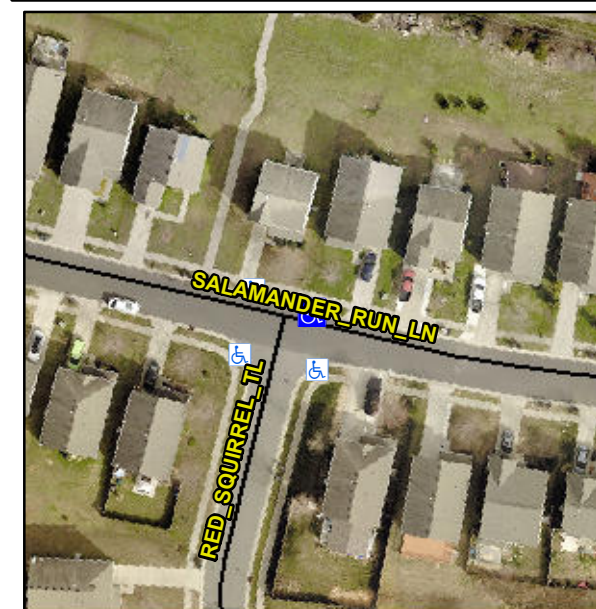
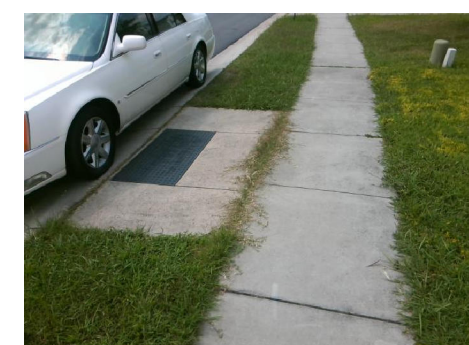
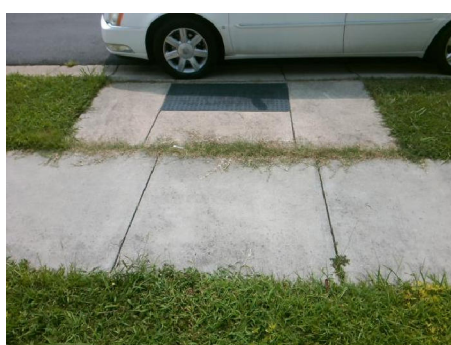
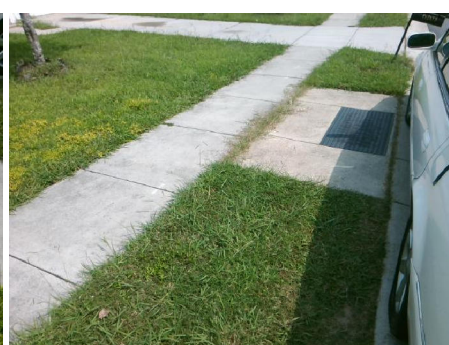
Not Found, R304.2.2-Perp, R304.3.2-Para, R304.5.3, R305.2

Compliance	Description	Data	Compliance	Description	Data
N/A	Ramp Length (in)	53.5	Yes	Ramp Slope (%)	6.1
Yes	Ramp Width (in)	48.0	Yes	Ramp XSlope (%)	1.6
N/A	Flare Type LT	Sloped	N/A	Flare Type RT	N/A
N/A	Flare Slope LT (%)	2.1	N/A	Flare Slope RT (%)	1.4
N/A	Flare Traversable LT?	No	N/A	Flare Traversable RT?	No
Yes	Landing Length (in)	48.5	Yes	DWS Provided?	Yes
Yes	Landing Width (in)	48.0	Yes	DWS Contrast?	Yes
No	Landing Slope (%)	2.9	Yes	DWS Length (in)	24.5
No	Landing X Slope (%)	2.6	Yes	DWS Full Width?	Yes
N/A	Landing Curb? (Y/N)	No	No	DWS Offset (in)	2.5
N/A	Shared Landing?	No			
Yes	Gutter Ponding?	No	Yes	Gutter Slope (%)	2.2
Yes	Gutter Lip Ht (in)	0.0	Yes	Gutter X Slope (%)	1.8
N/A	Painted X Walk1?	No	N/A	Painted X Walk2?	N/A
	X Walk 1 Direction	To S		X Walk 2 Direction	N/A
N/A	X Walk 1 Width (in)	N/A	N/A	X Walk 2 Width (in)	N/A
	X Walk 1 Slope (%)	2.9		X Walk 2 Slope (%)	N/A
	X Walk 1 X Slope (%)	1.5		X Walk 2 X Slope (%)	N/A

N/A	Ramp inside XWalk1?	N/A	N/A	Ramp inside XWalk2?	N/A
	Road Slope (%)	N/A	N/A	Clear Space?	Yes
	Road X Slope (%)	N/A	N/A	Clear Space to XWalk (in)	N/A
Yes	Any Obstructions?	No	Yes	Storm Grate/Utility Hazard?	No
	Obstruction Type			Storm Grate/Utility Type	
		N/A			N/A
			Yes	Surface Condition? (G/P)	Good

Remove & Replace Entire Ramp.
