Access Compliance Report

Public Rights-of-Way

(Curb Ramps)

Intersection ID: 10040584		Main Street: W_ARROWWOOD_RD		Cross Street: N/A		Location:		NW											
ADA ID: D6A51C3110A4		Ramp Type: Directional1		Initial Pass/Fail: Pass		Overall Compliance: No		Severity Score: 10											
Codes/Mitigation Info/Possible Solution				Field Measurements/Component Compliance

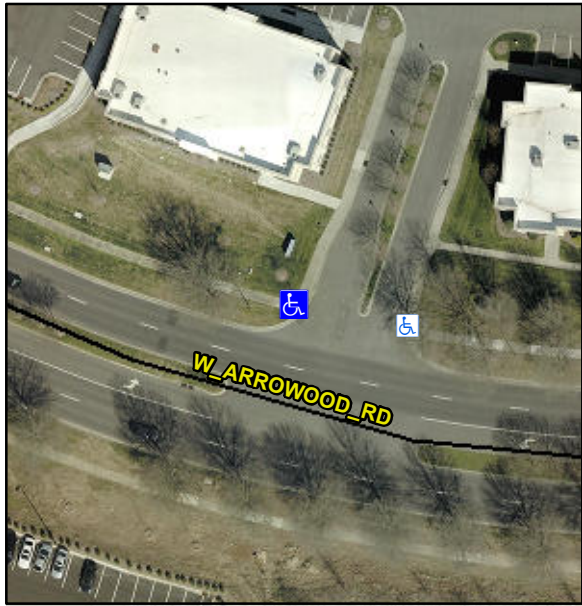
<div>Street 1 NameENTRANCE</div> <div>Stop Condition-Street 1StopSign</div> <div>Street 2 NameN/A</div> <div>Stop Condition-Street 2N/A</div>				Possible Solutions:		Compliance		Description		Data		Compliance		Description		Data			
				Remove & Replace Entire Ramp.		N/A		Ramp Length (in)		69.0		No		Grade Break?		No			
						Yes		Ramp Width (in)		61.0		N/A		Grade Break Slope (%)		5.8			
						Yes		Ramp Slope (%)		7.2		N/A		Grade Break XSlope (%)		5.0			
						Yes		Ramp XSlope (%)		0.4									
						N/A		Flare Type LT		N/A		N/A		Flare Type RT		N/A			
						N/A		Flare Slope LT (%)		9.2		Yes		Flare Slope RT (%)		4.2

Surveyor Notes:		N/A		N/A		Flare Traversable LT?		No		N/A		Flare Traversable RT?		Yes	
								Yes		Landing Length (in)		59.0		No		DWS Provided?		No	
								Yes		Landing Width (in)		60.0		N/A		DWS Contrast?		No	
				No		Landing Slope (%)		6.5		N/A		DWS Length (in)		N/A					
				Yes		Landing X Slope (%)		1.2		N/A		DWS Full Width?		No					
				N/A		Landing Curb? (Y/N)		N/A		N/A		DWS Offset LT (in)		N/A					
				N/A		Shared Landing?		No		N/A		DWS Offset RT (in)		N/A					
				Yes		Gutter Ponding?		No		Yes		Gutter Slope (%)		2.4					
				Yes		Gutter Lip Ht (in)		0.0		Yes		Gutter X Slope (%)		1.3					
				N/A		Painted X Walk1?		No				Road Slope (%)		3.4					
						X Walk 1 Direction		To E				Road X Slope (%)		1.3					
						X Walk 1 Width (in)		N/A				Clear Space?		Yes					
						X Walk 1 Slope (%)		3.4		N/A		Clear Space to XWalk (in)		N/A					
						X Walk 1 X Slope (%)		1.3		Yes		Storm Grate/Utility Hazard?		No

N/A		Ramp inside XWalk1?		N/A				Storm Grate/Utility Type							
				Yes		Any Obstructions?		No						N/A					
						Obstruction Type				Yes		Surface Condition? (G/P)		Good					
										N/A		No		Curb Slope (%)		15.5			
Total Cost:				\$		1600.00
